ANNEX 19

PROGRAM TO IMPROVE EXISTING ROADS

REPORT OF CONDITION OF ROUTES G-25 AND G-455

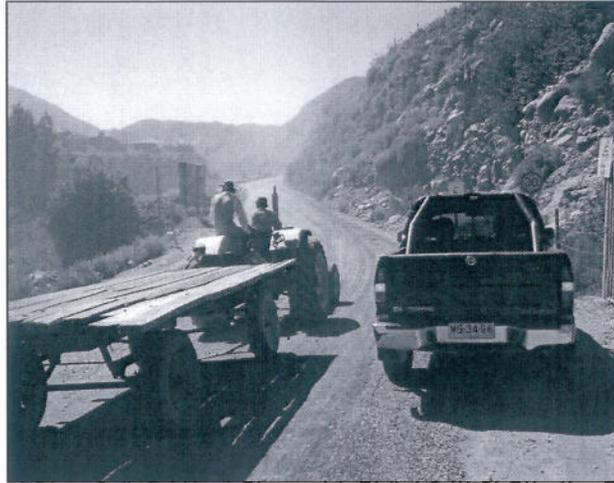
A 6 to 7m wide granular road starts after the bridge. This section coincides with the hill with an estimated slope of 10%, which along with the deficiencies in the sub-grade material shows surface waving (deep) which makes traffic of trucks difficult.

Image 1 Hill section of the road with surface treatment failed due to traction on slope and poor quality of sub-grade.

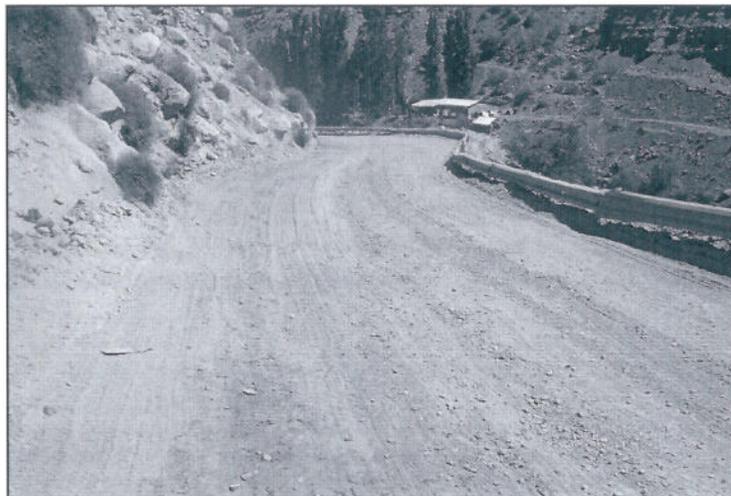
Image 2 Section in hill, backward view.

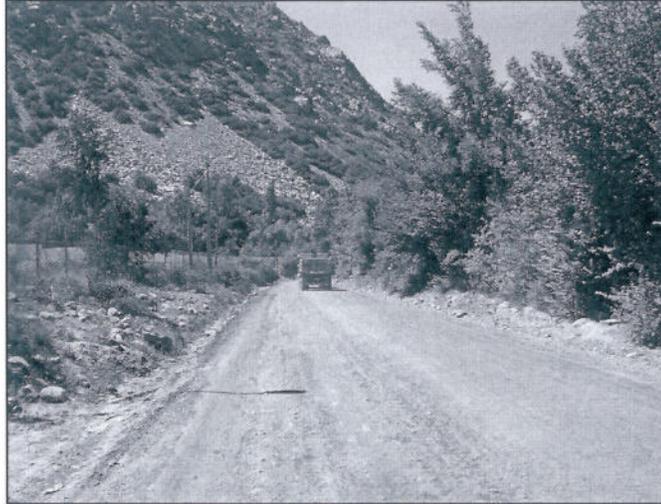
Image 3 Section with dust suppression treatment.

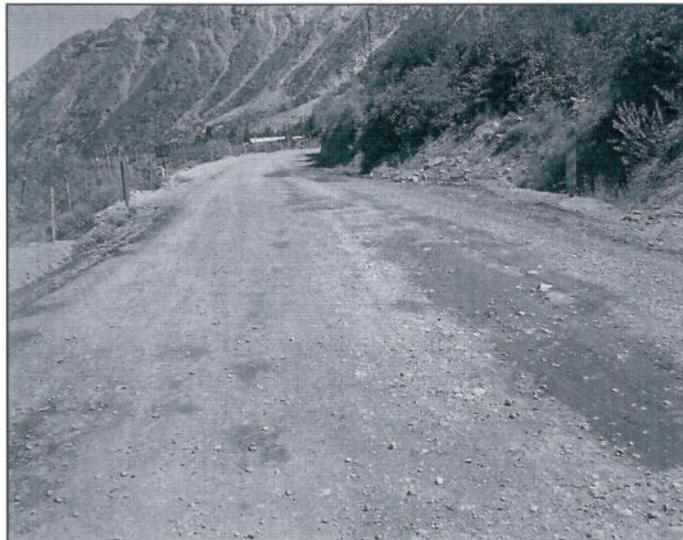
Image 4 Section with failure in dust suppression treatment failed due to water on the mat.

Water enters without control to the road and early destroys the surface treatment with bischofite.

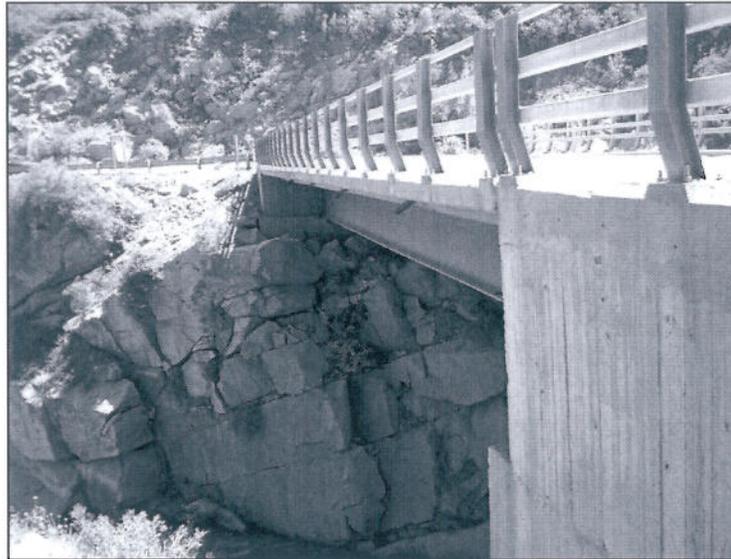
Pk 4.3 Puente Volcán is 25m long and has a 7m boardwalk; it is in good conditions and is a recent construction.

Image 5 Puente Volcán.

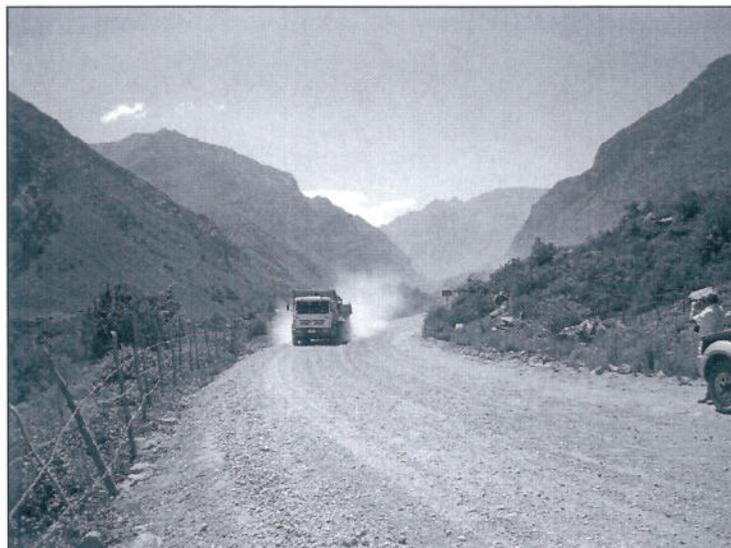
Image 6 Section without dust suppression

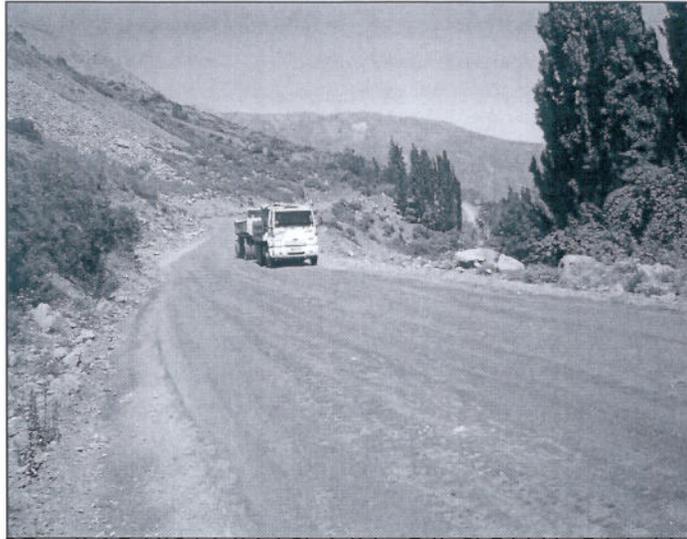
Image 7 Section with bischofite treatment due to houses adjacent to the road.

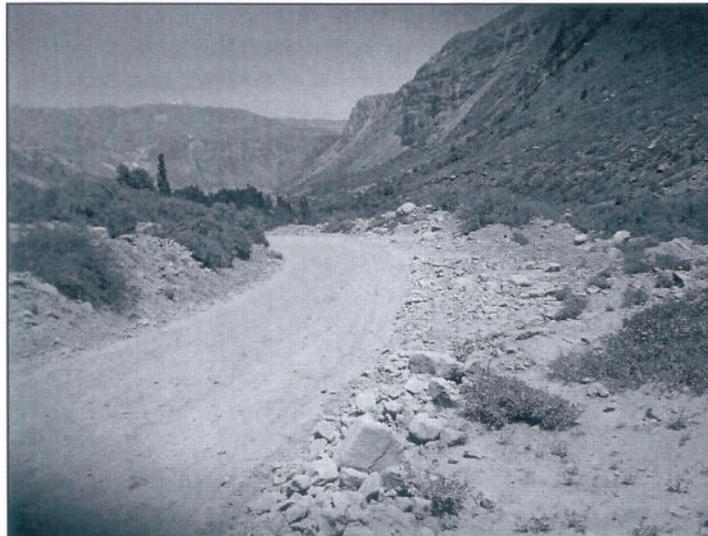
In Pk 8.7 the action of cobble with drifting material produces contamination on the mat; this situation is common until Pk 12.

Image 8 Road with cobble mat due to cobble transferring material to the road platform.

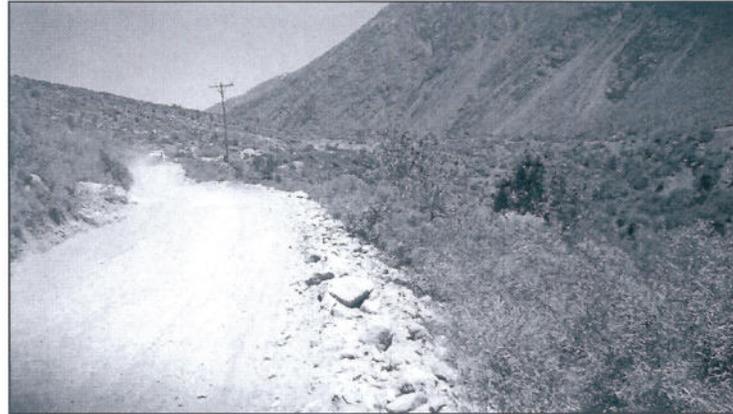
Pk 13.8 to 20 near the crushing plant Volcán, the road has a scarce presence of the mat; what is present results from drifting of coarse material from the action of cobble crossing the road.

Image 9 Representative section of Pk 13.8-Pk 20, drifting material in sidewalk.

- Replace granular cobble road $CBR \geq 60\%$ from Pk 13.8-Pk 20 for a 7m width and 15cm thick.
- Laying out of road signs from Km. 12 to km 23.3; a total of 50 signs and 60 vertical delineators are estimated.
- Placement of road fenders in curves without visibility and risk of falling for vehicles from a great height, from km 12 to km 23.3. (A total of 200m is estimated)
- An engineering structure, a $d=0.80\text{m}$ diameter corrugated tube, in the area where mat will be replaced, approx. at Km. 20
- Annual watering using bischofite¹ with dust suppression effect: one watering per season to all the length of the road (23Km) including the section to be paved by the MOP.

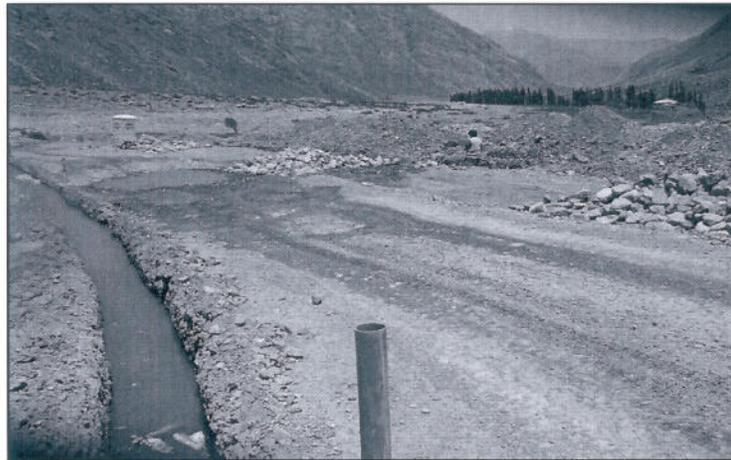
Image 10 Pk 16.8 Drip in construction uses natural rock; MOP work.

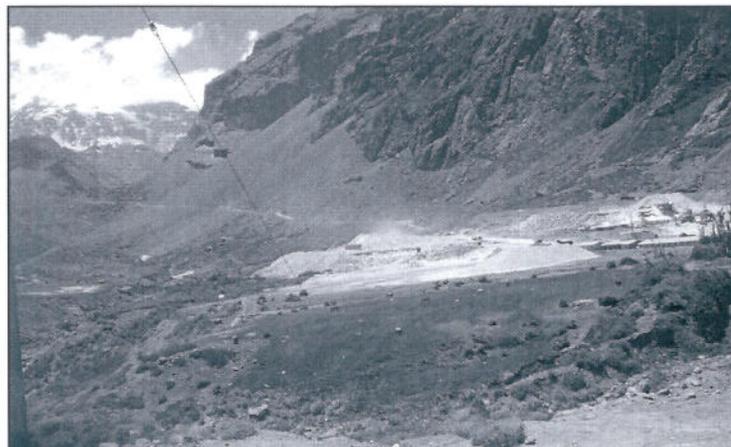
Image 11 Pk 20 Plan view of El Volcán crushing plant and view of route to Baños Colina.

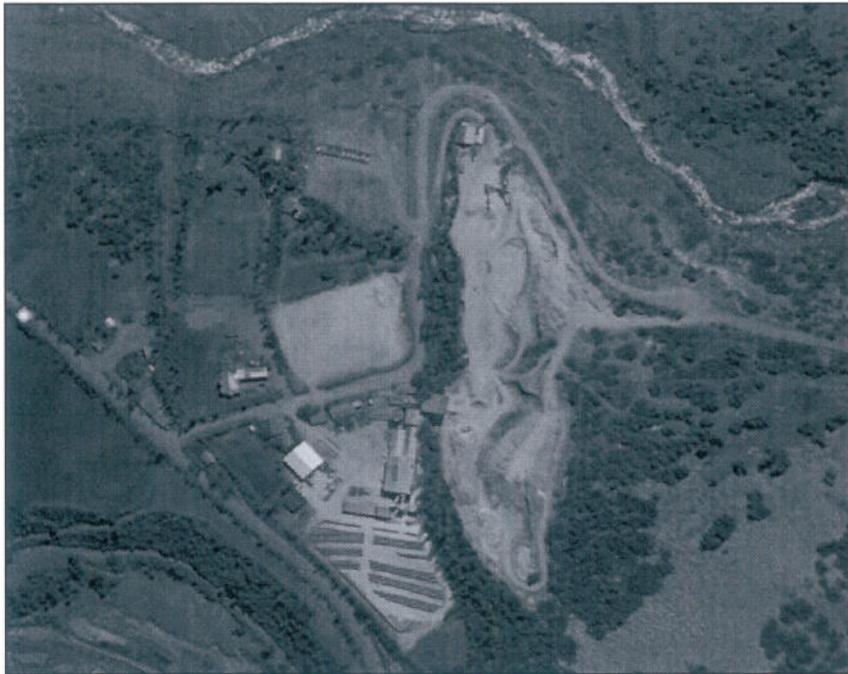
Image Y-1Pk 0.0 Planta Industrial Romeral. Route G-455 crosses the facilities of the plant.

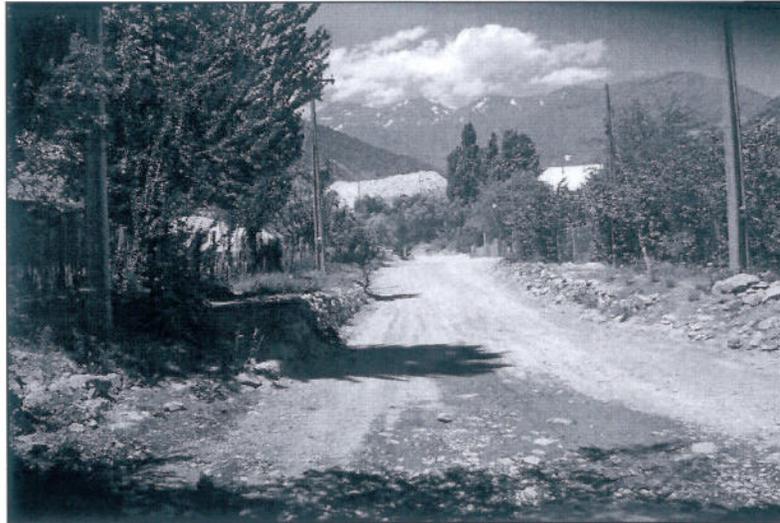
The first 700m of the road have a cobble mat 6m wide have coarse granulometry and is in regular conditions.

Image Y-2 Pk 0.0 Route G-455, forward view.

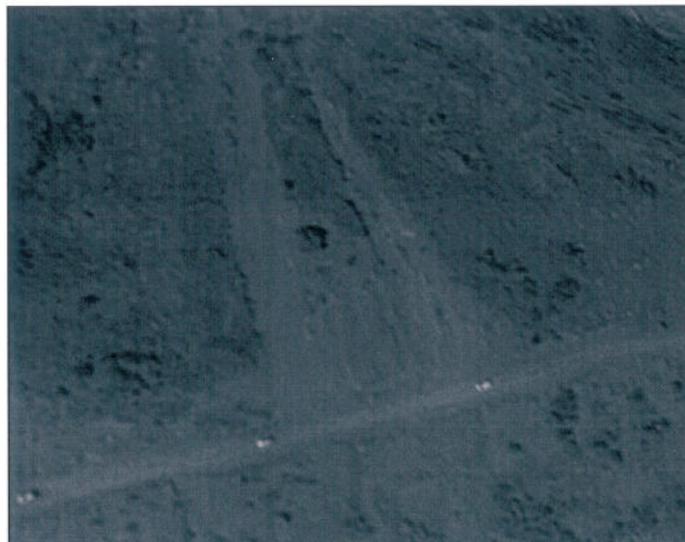
The main problem with this section is related to two areas that have permanent activity which translates in a constant dragging of material which reaches the road. This situation occurs in Pk 3.6 and 4.2; in the latter the volume of material falling needs to be removed using larger machinery.

Image Y-3 Pk 4.2 Plan view, ejectment cone active with drifting material on board.

- Construction of two dips in rock, section Pk 18
- Build masonry wall lower than 1m high to separate the edge and contain spillages as to allow manual clearing and/or with equipment. In sections 40m in Pk 3.6, 80m Pk 4.2 and 300m from Pk 17.8 to Pk 18.8.

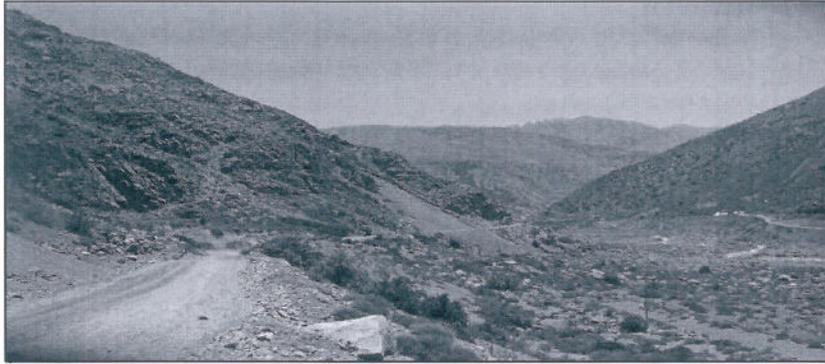
Image Y-4 Pk 3.6 and 4.2 Backward view, ejection cones active with drifting material on board.

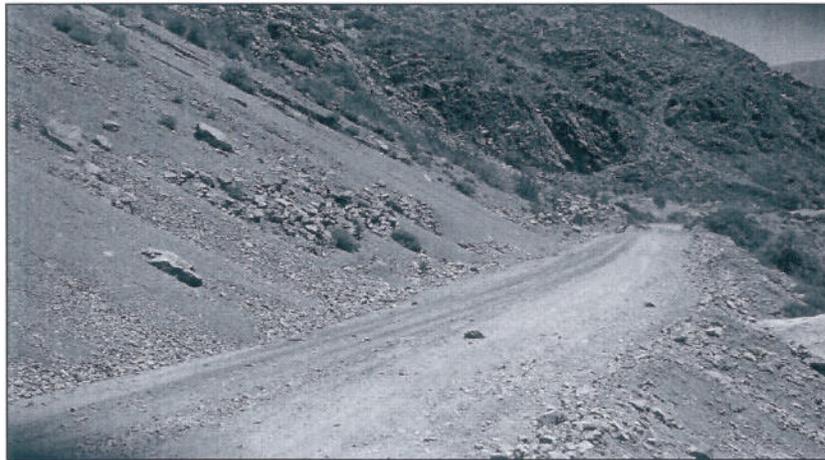
Image Y-5 Pk 4.2 Material constantly falling on the board.

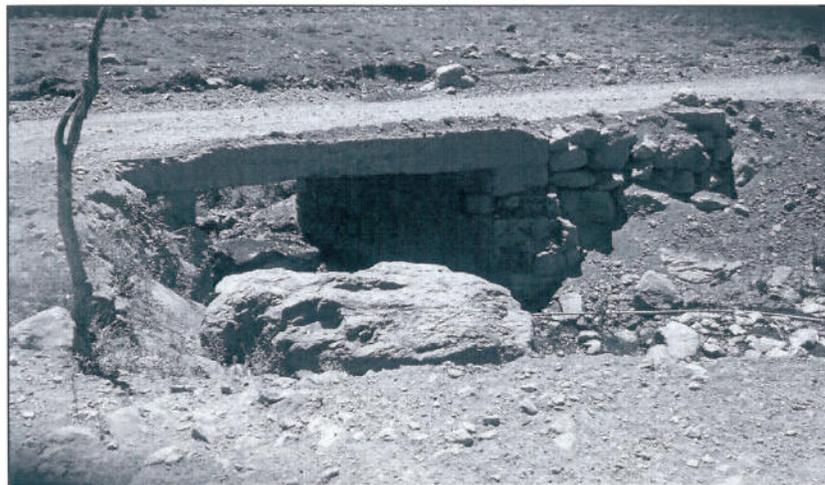
Image -6 Pk 9.3 4m narrow slab reduces the width of the board to 3m.

- Increase size of three concrete boxes for sewage of 4 to 7m.
- Annual watering with dust suppression effect bischofite; one watering run per season is estimated for all the length of the road (22Km.)

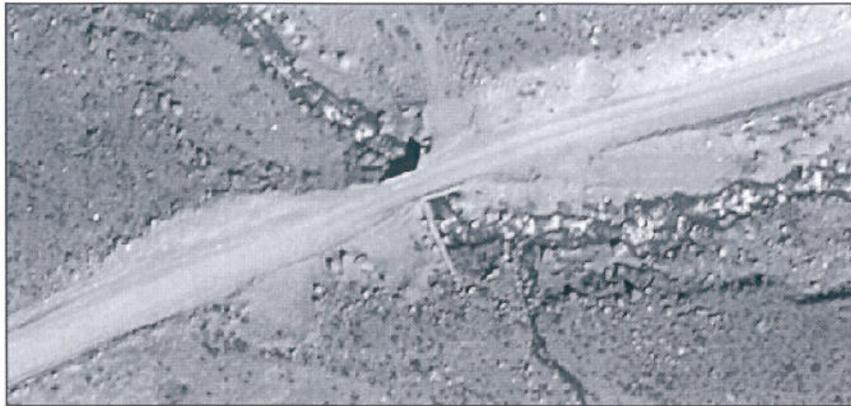
Image Y-7 Pk 9.3 Plan view.

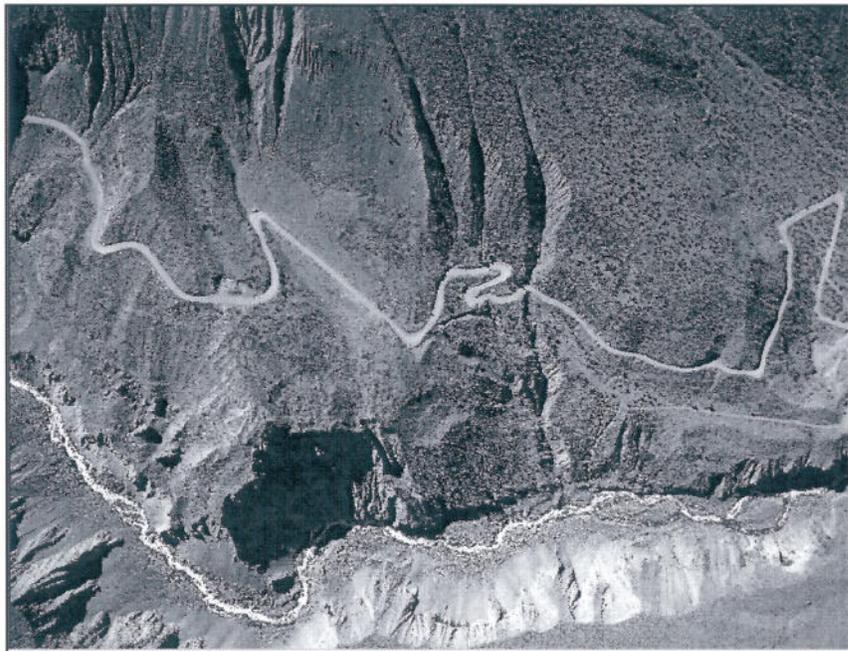
It is possible to see in Image Y-8 the geometry of the road; there currently is a permanent traffic of trucks hauling material to Romeral plant located in Pk 0.0. Initially it should not have any obstacles for the transportation of material and equipment.

Image Y-8 Pk 10.5 to 12.5 is the section with greater restriction in plan view and vertical elevation. Pk 12 road in cobble.

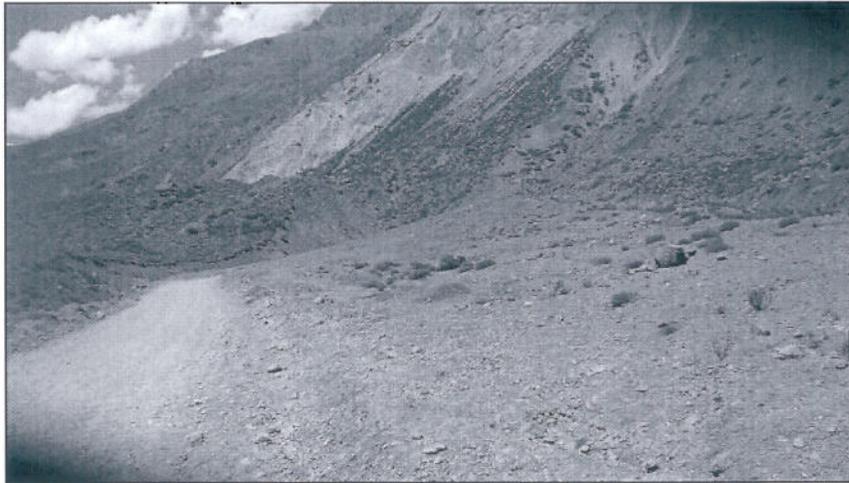
Image Y-9, Pk 12 road in cobble.

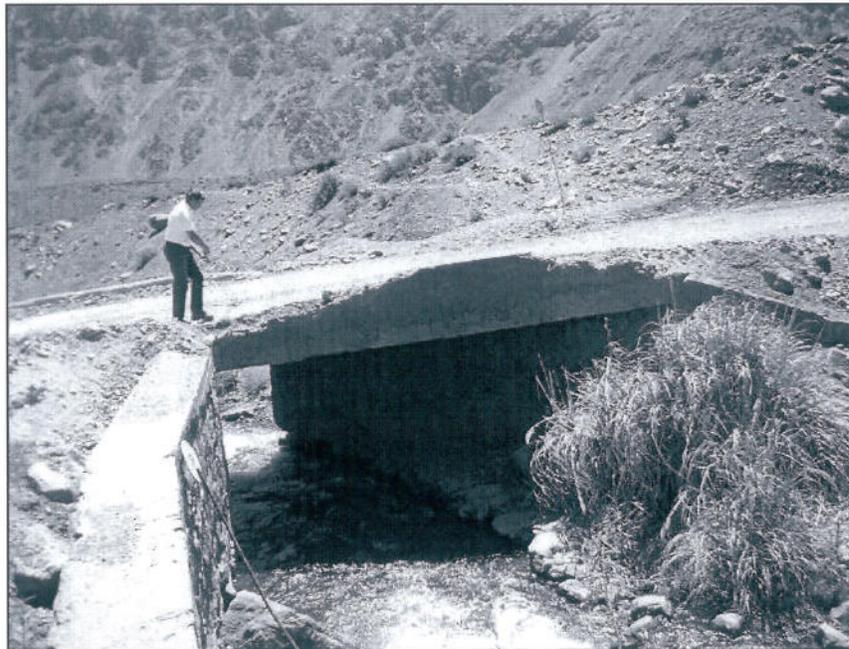
Image -10 Pk 14.7, a 4m narrow slab reduces the width of the board to 3m.

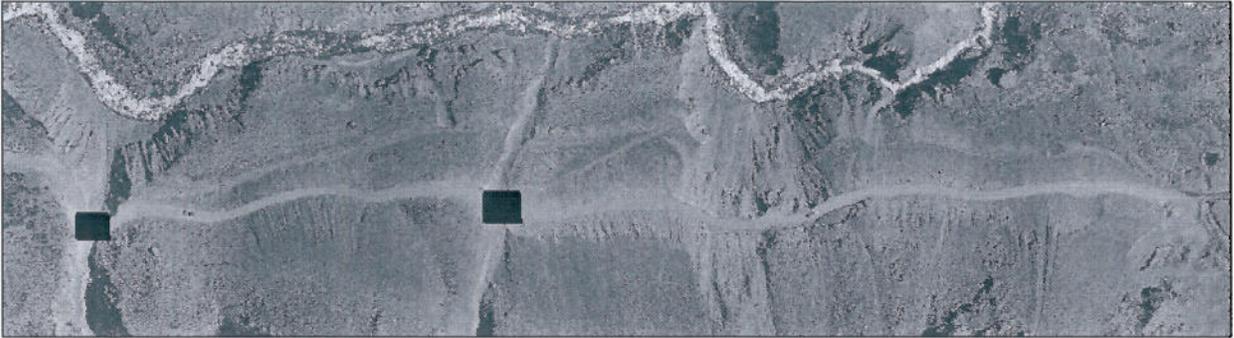
From Pk 17.8 to Pk 18.6 approx., a section of the road runs with its platform excavated in a cut; the hill's angle is near 45° and there is continuous spillage of material; also, a couple of dips are missing as to intersect a number of brooks.

Image Y-11 Pk 17.8 to Pk 18.6 Side excavate in cut, 5 to 6m wide; dips are missing and drifting material on the side.

- Engineering structures, $d=0.80\text{m}$ diameter corrugated tube, in the area, approx. at km 6 where a loading station for water trucks is located.
- Replace granular cobble road $CBR > 60\%$ from Pk 17.8 to Pk 18.3 for a 7m width and 15cm thick.

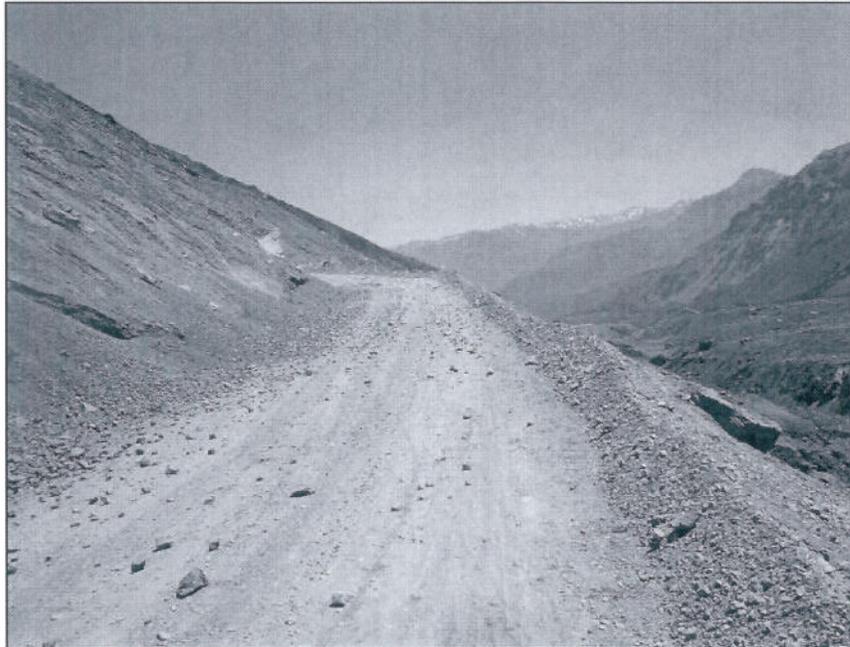
Image Y-12 Pk 18 Material constantly falling on the board

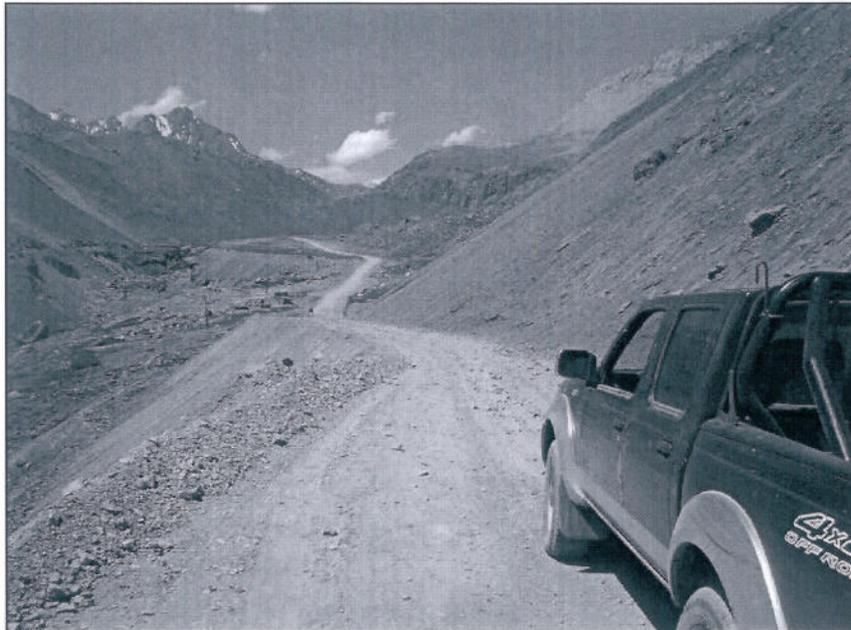
Image Y-13 Pk 18 Material constantly falling on the side. Forward View.
