ANNEX 2

Photograph Log

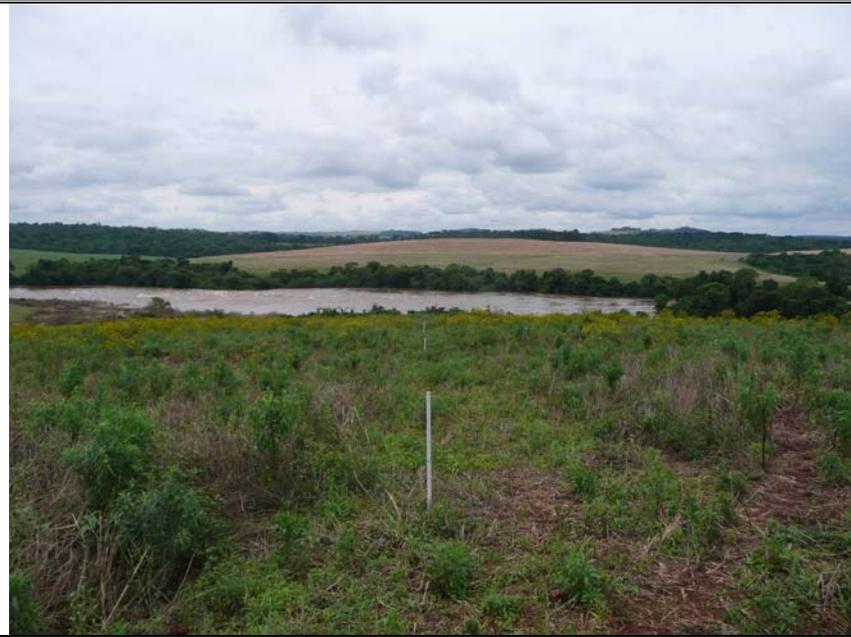
Photo 1. General conditions in the area of the future dam. The area has a predominant agricultural land use. The white stake marks the location of the axis of the future dam.

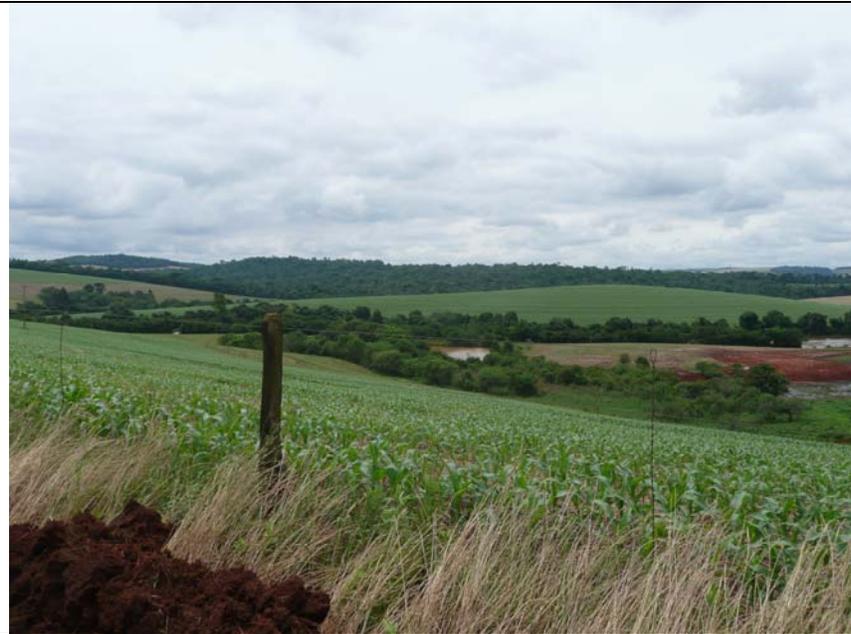
Photo 2. General conditions near the future dam. Corn crop is observed in the foreground.

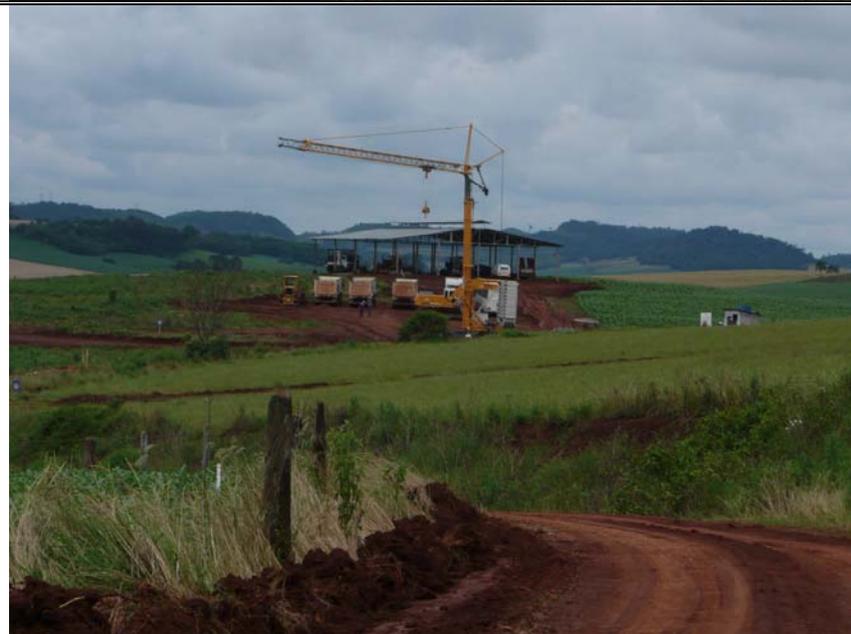
Photo 3. Construction of an equipment storage facility near the future dam.

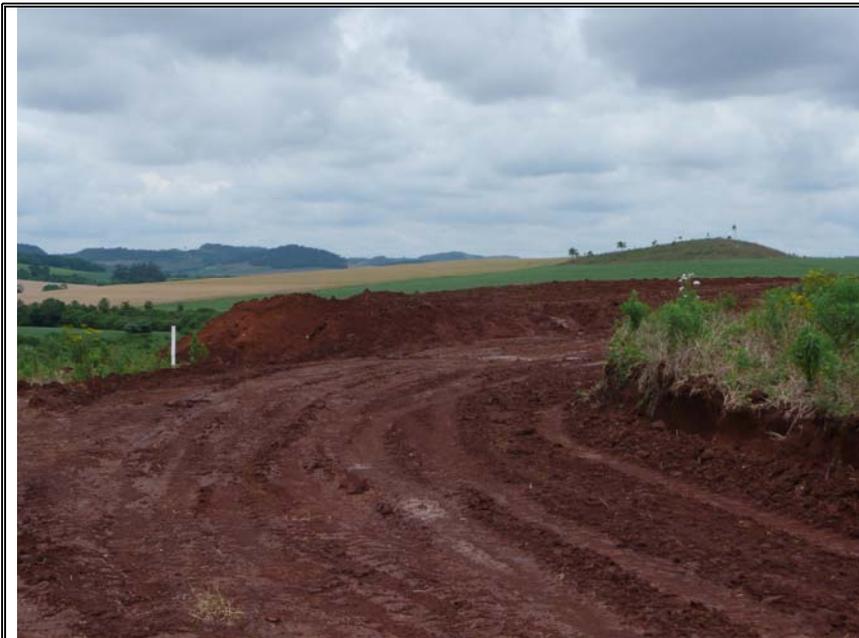
Photo 4. Access road to the area of the future power house.

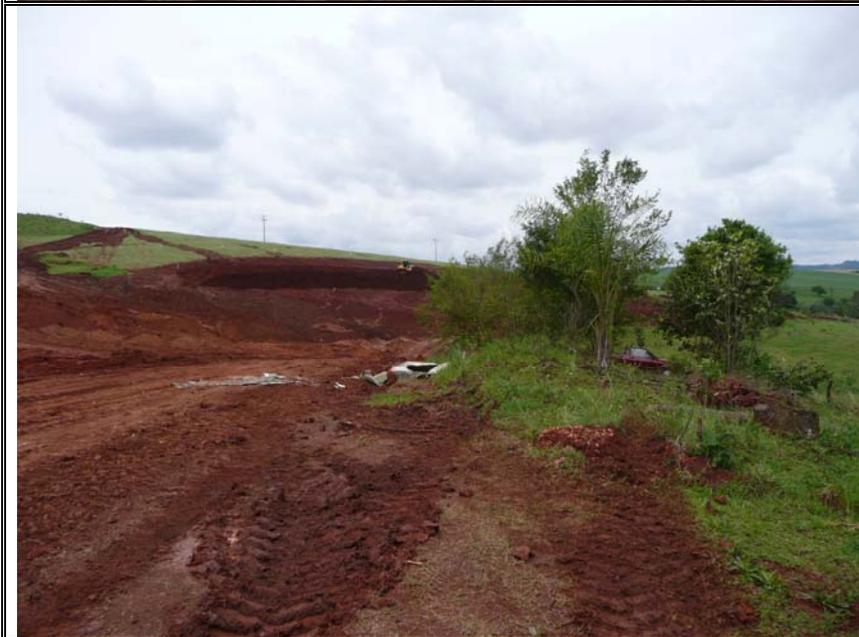
Photo 5. Initial construction in the area of the future power house.

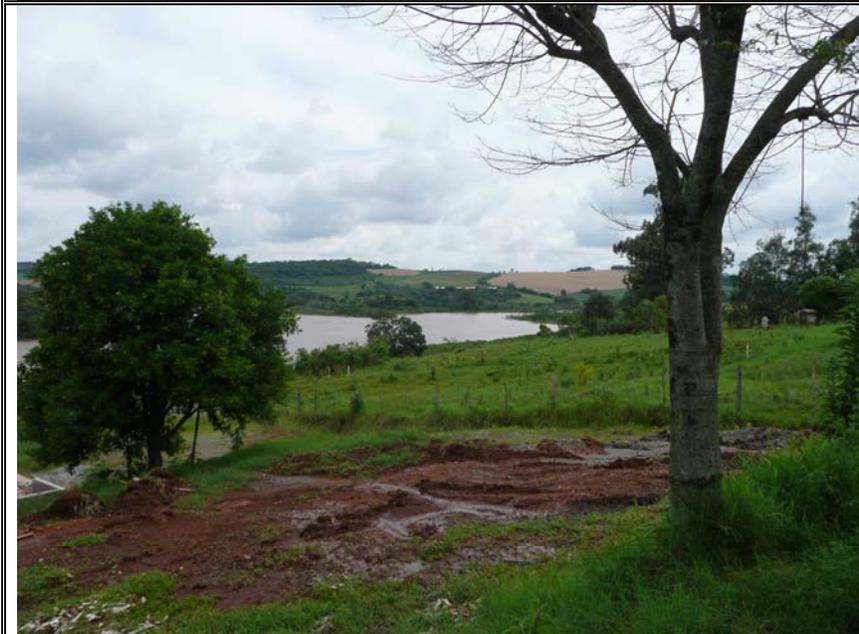
Photo 6. General conditions around the future power house and a residence in the background.

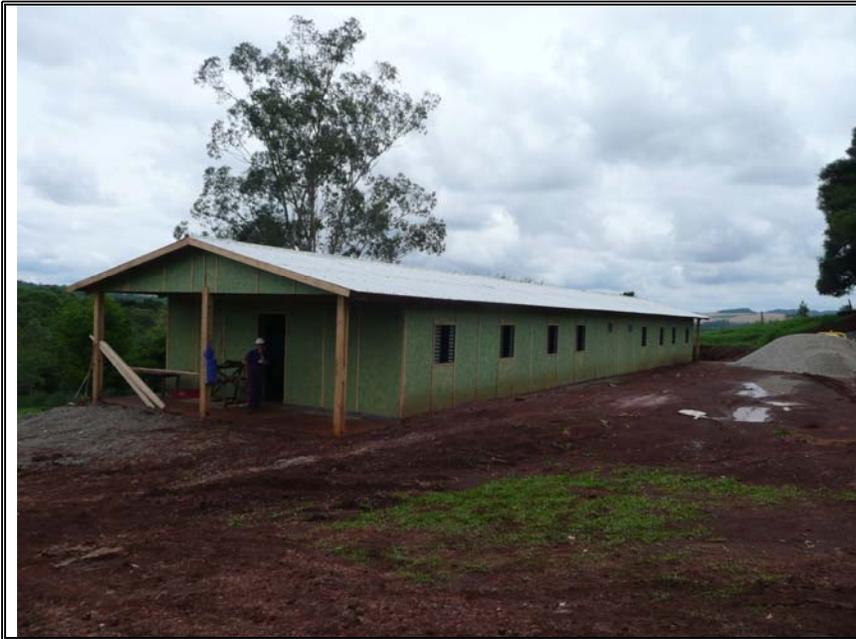
Photo 7. Construction of the new staging area and onsite living facilities near the Chapecó River.

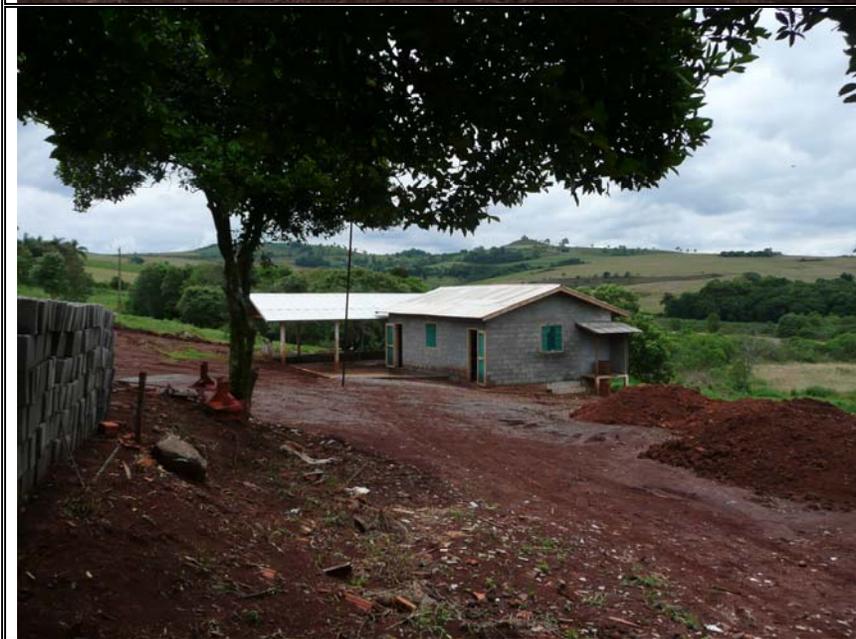
Photo 8. Construction of the cafeteria to support the new staging facility near the Chapecó River.

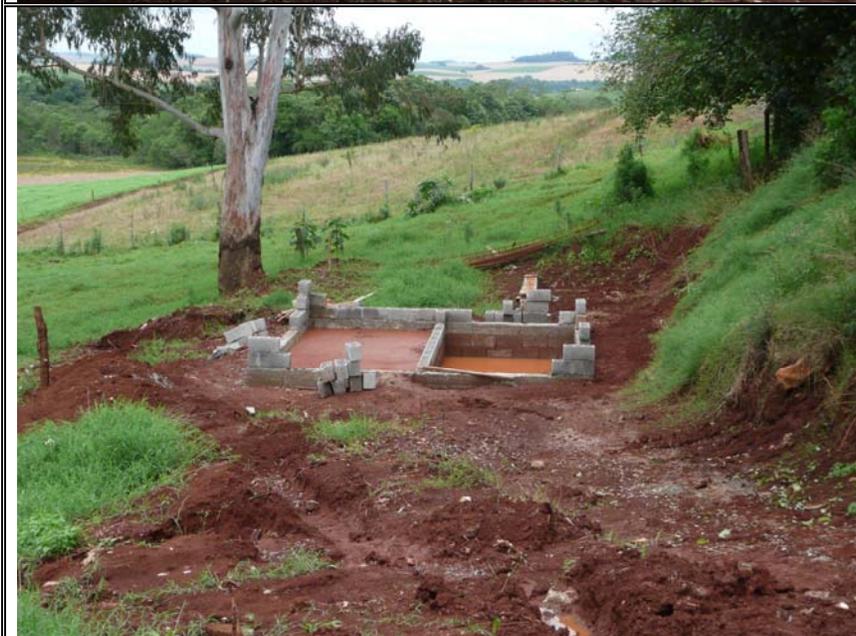
Photo 9. Construction of a new septic tank system for the new staging facility.

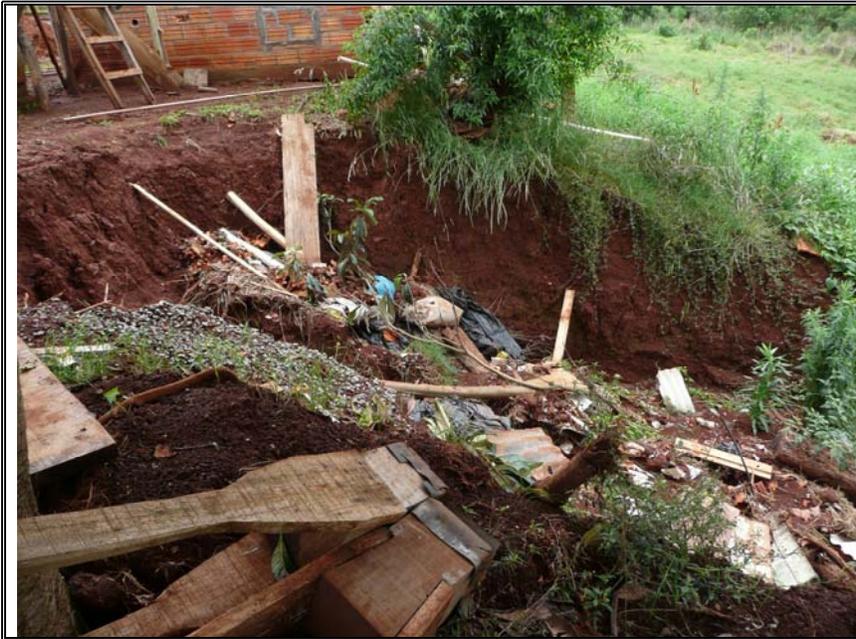
Photo 10. Waste in a ditch between the onsite lodging facility and the cafeteria. Workers said that the trash is from former owners of the land.

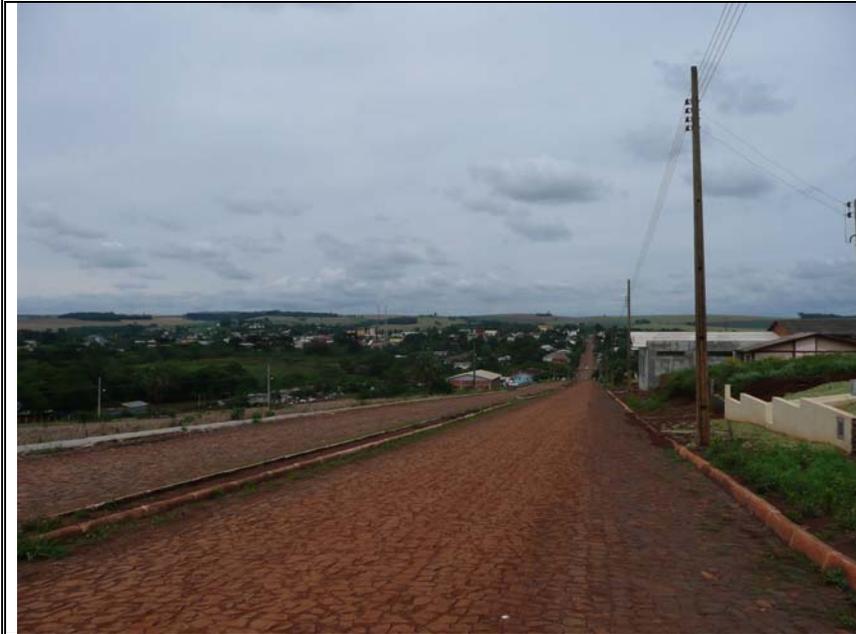
Photo 11. General conditions in São Domingos.

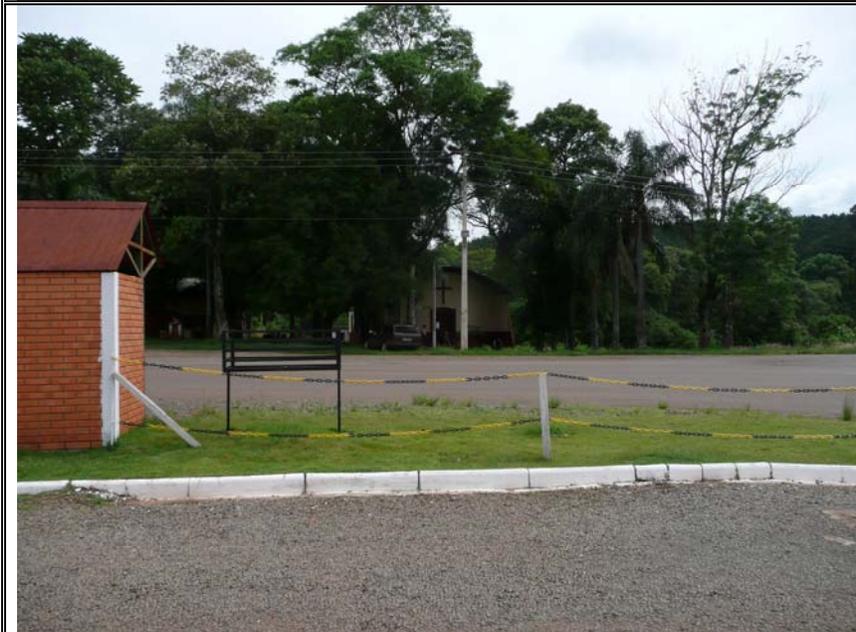
Photo 12. Entrance of the main Project construction staging area, in the community of São Domingos. A community church is located across the main entrance.

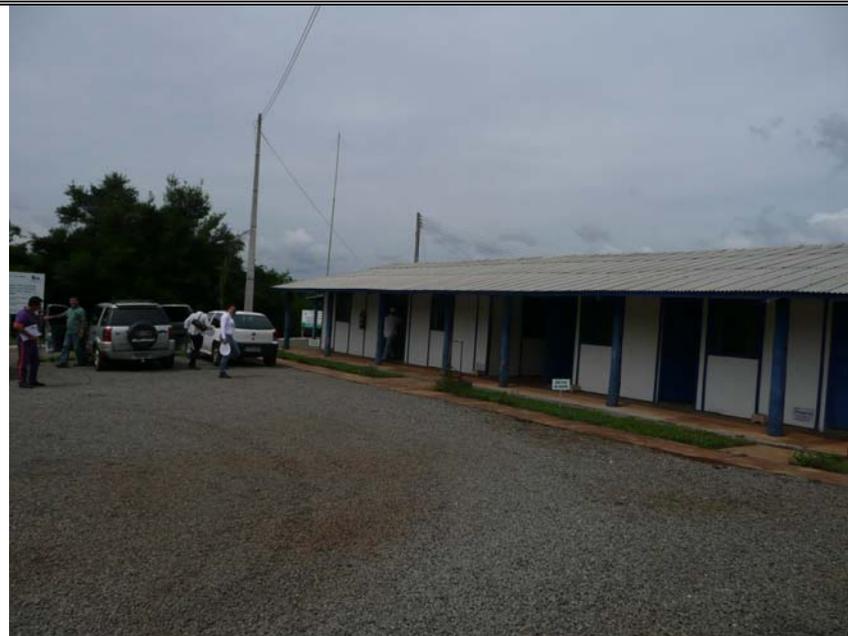
Photo 13. Parking area and administration building near the main entrance of the Project construction staging area.

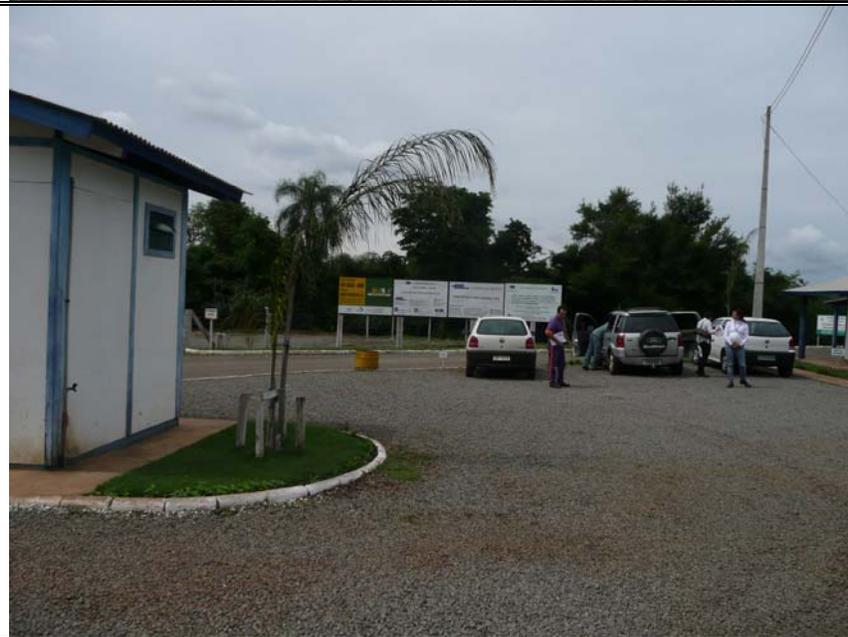
Photo 14. General conditions in the area of the Project main staging area in São Domingos, along inter-state highway SC-480. The property beyond the fence, in the background, is owned by PCH Ludesa.

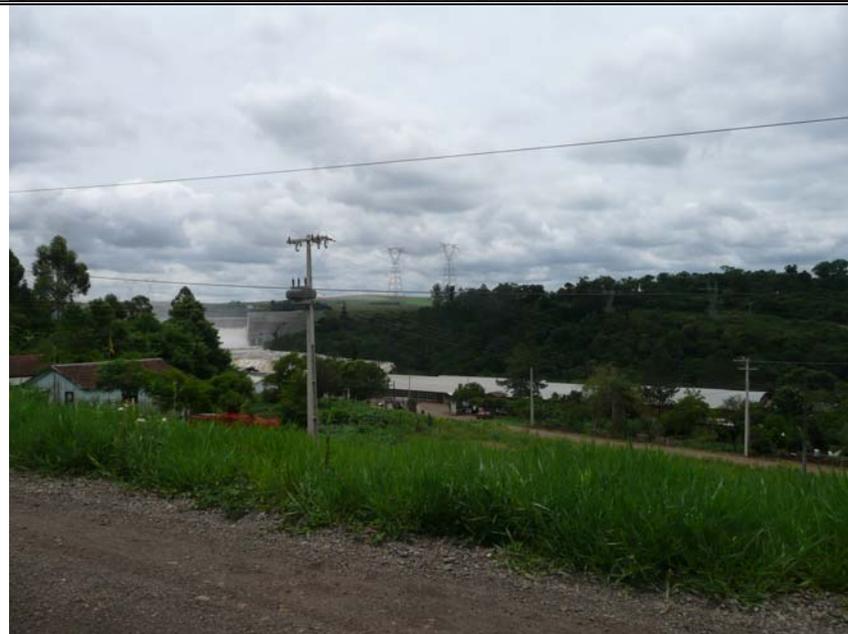
Photo 15. The dam of the PCH Ludesa is located near the Project main staging area and is visible from SC-480.

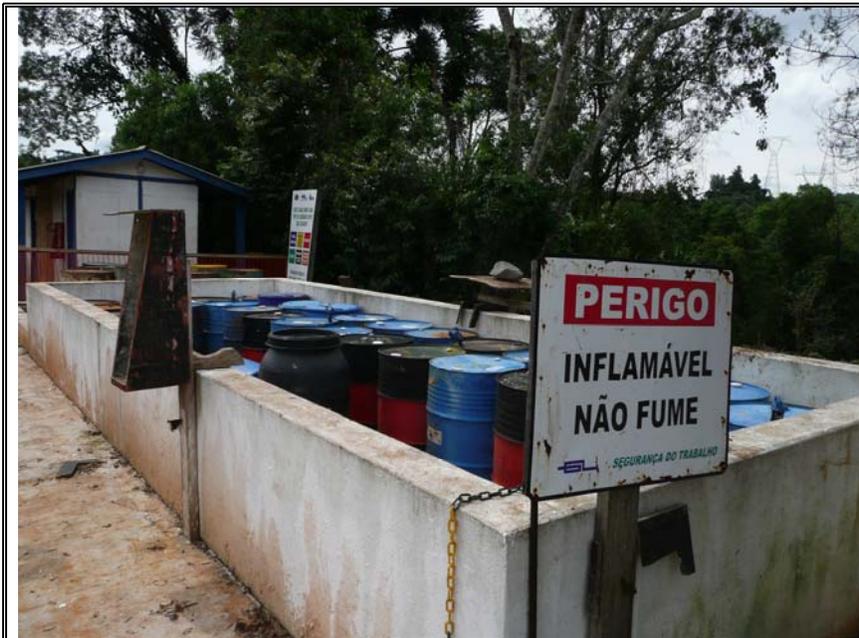
Photo 16. Fuel storage area in the Project main staging area.

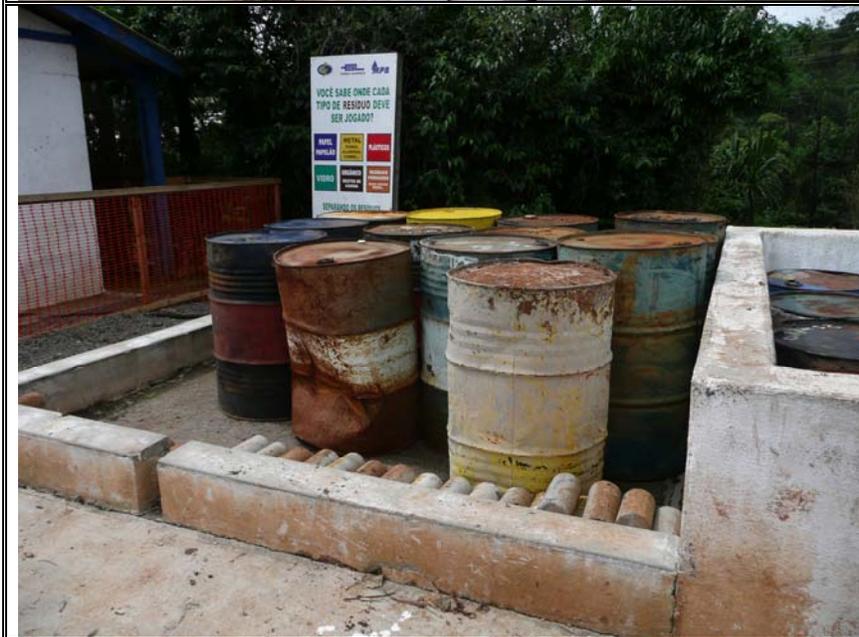
Photo 17. Old products left from the construction of the PCH Ludesa.

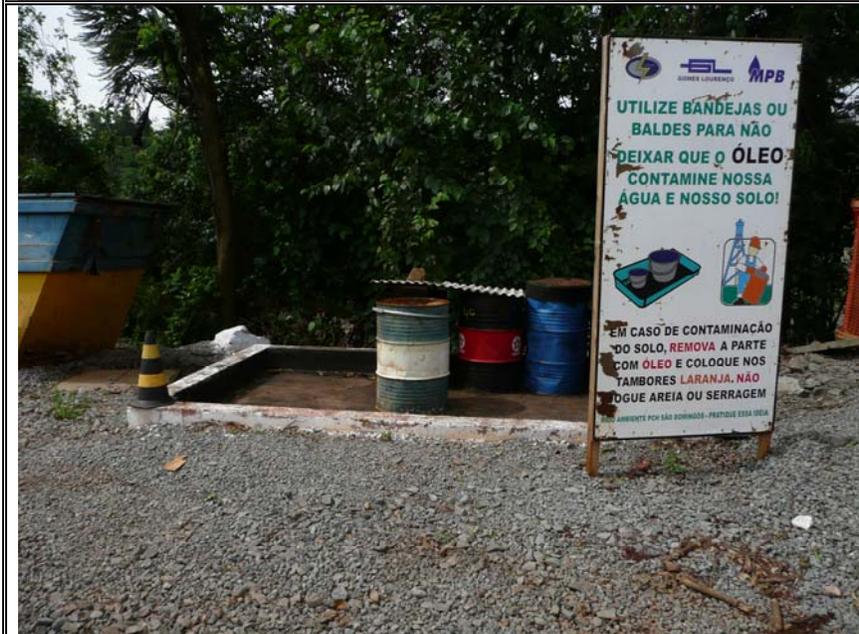
Photo 18. Used oil storage area in the Project main staging area.

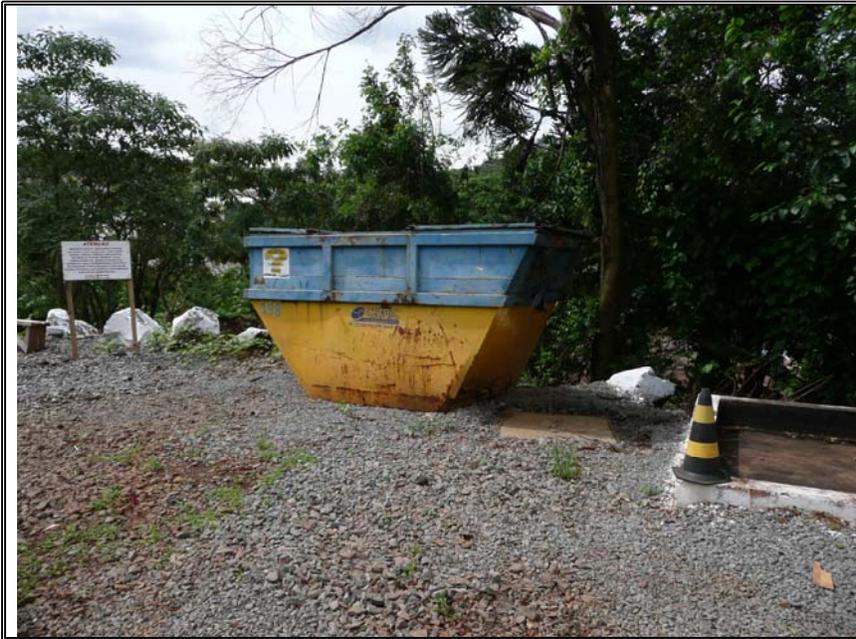
Photo 19. Container used for temporary storage of hazardous wastes.

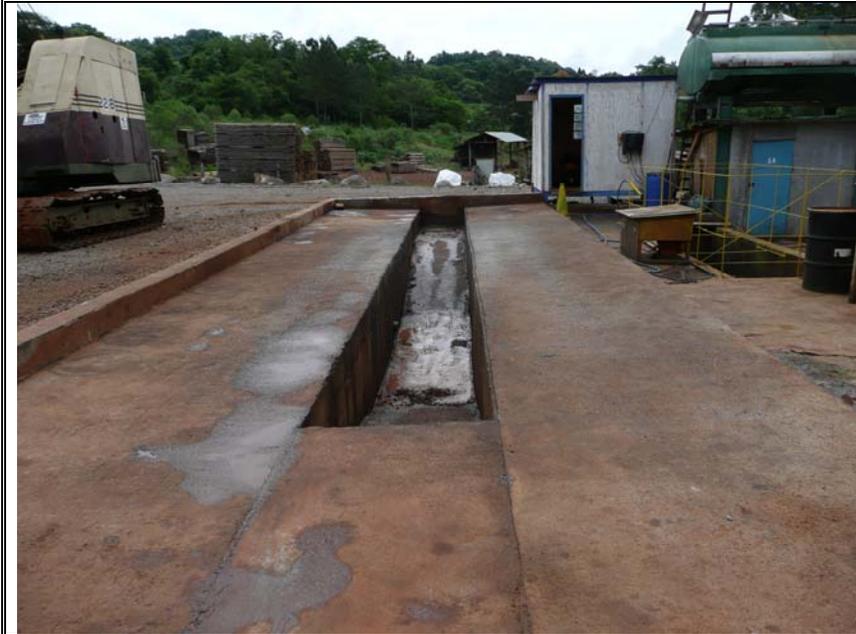
Photo 20. Vehicle/truck washing/maintenance area.

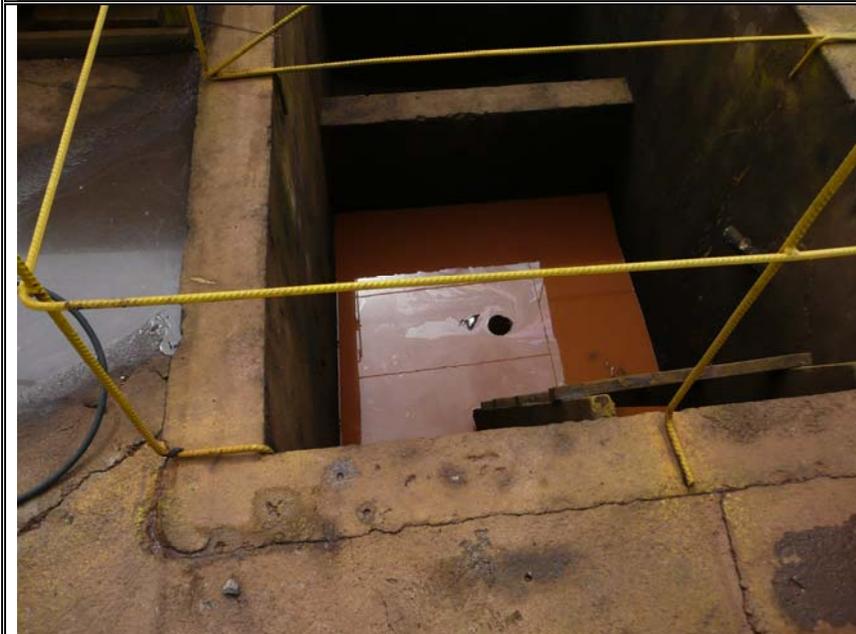
Photo 21. View of the inside of the oil/water separator in the area of vehicle/truck washing/maintenance area.

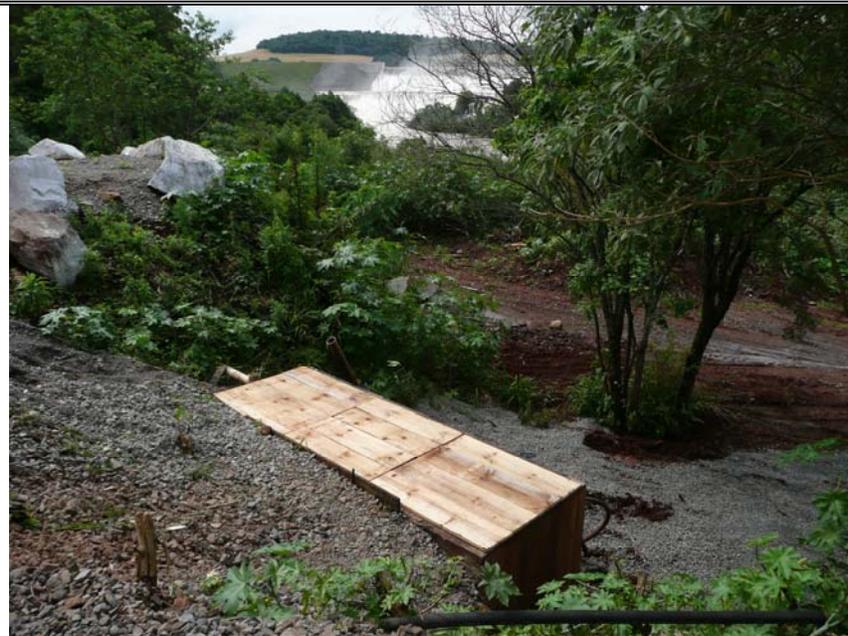
Photo 22. Condition of the oil/water separator. In the background is the dam of the PCH Ludesa.

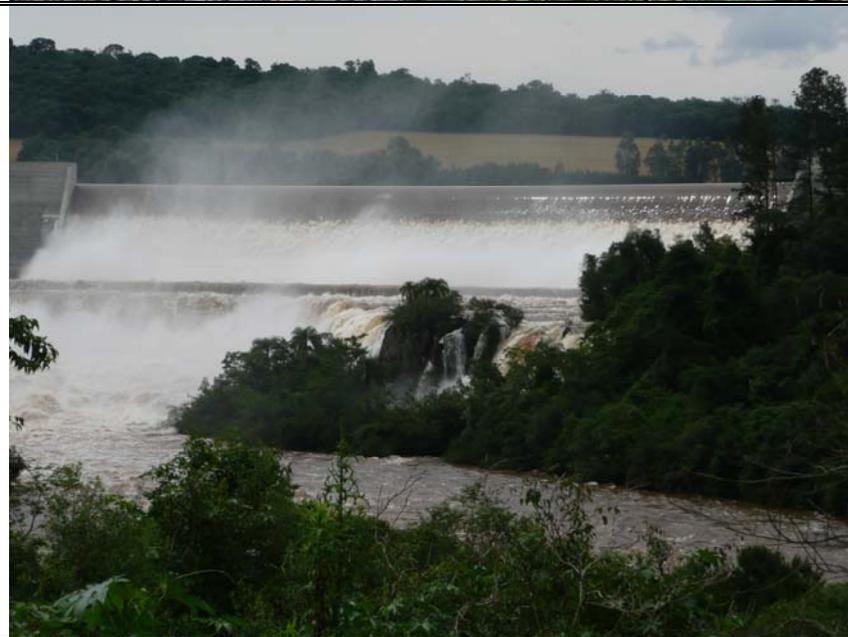
Photo 23. Close-up of the PCH Ludesa dam, as observed from the main staging area.

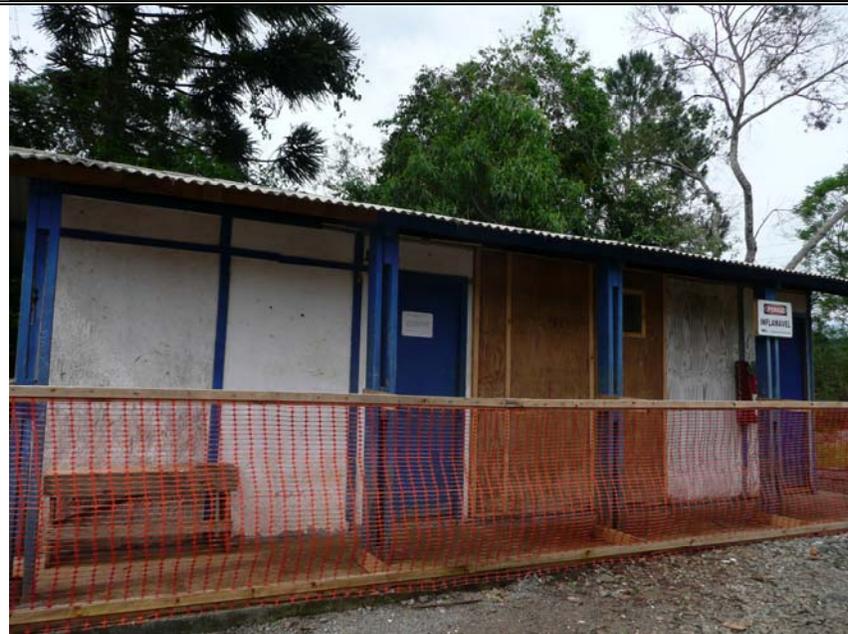
Photo 24. Product storage area in the Project main staging area.

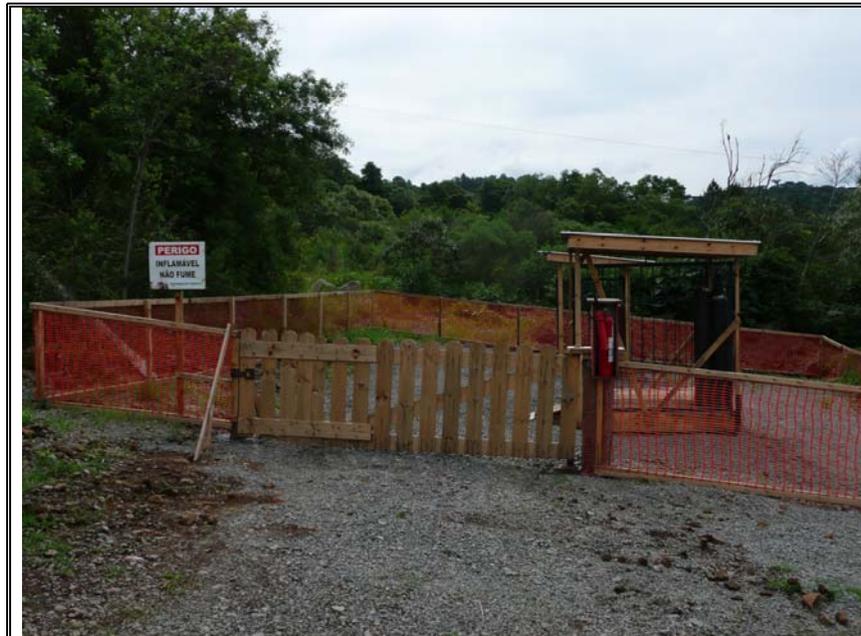
Photo 25. Compressed air cylinder storage area.

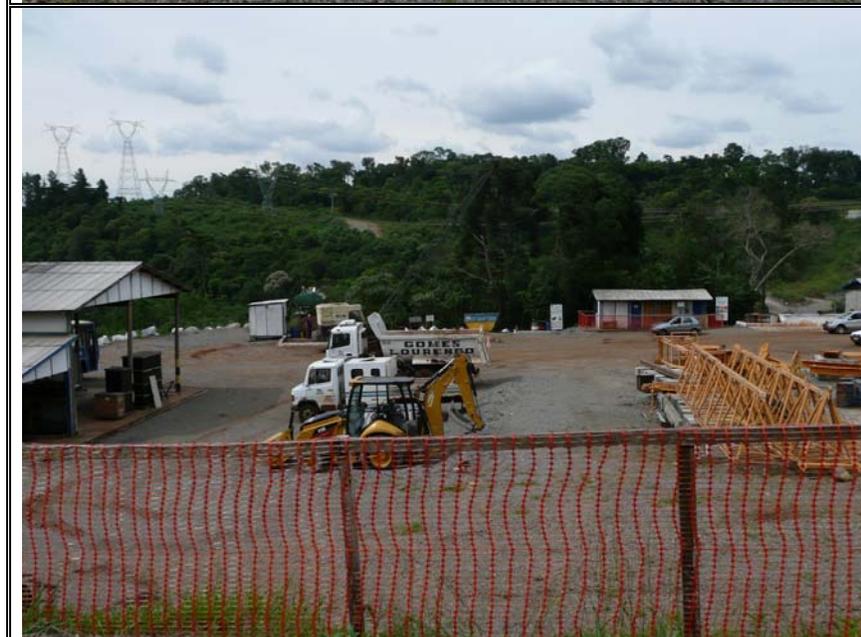
Photo 26. General conditions in the Project main staging area, in São Domingos.

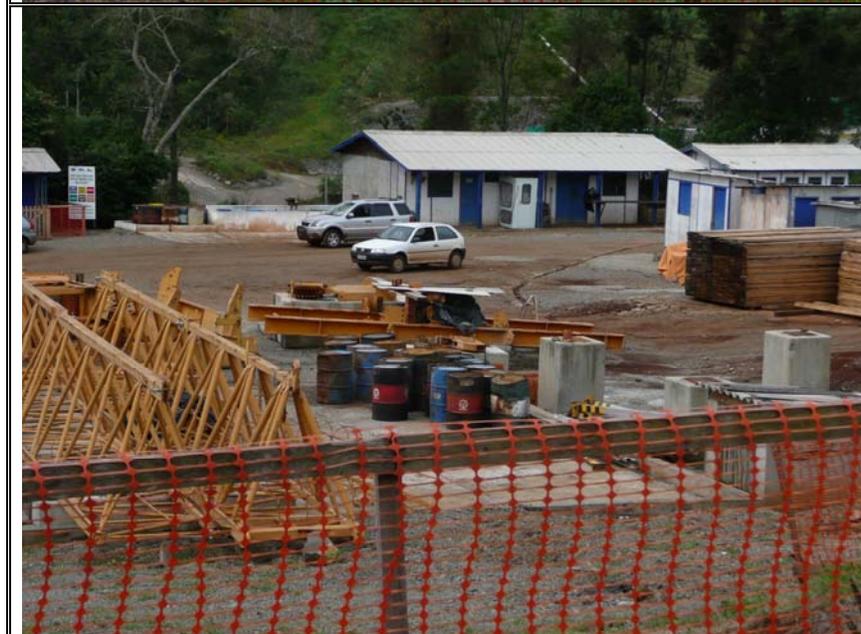
Photo 27. General conditions in the Project main staging area. Drums observed in the picture are supposedly concrete additive left from the construction of PCH Ludesa.

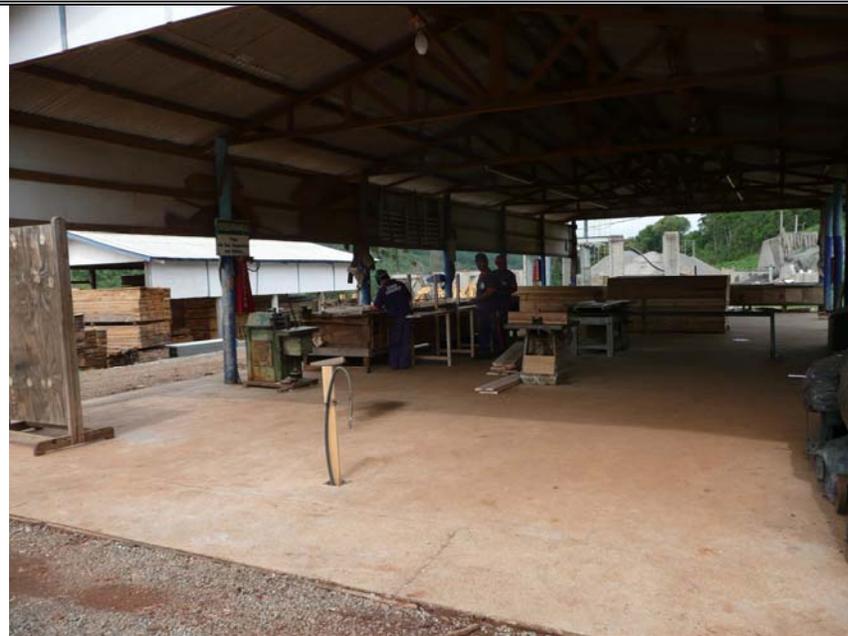
Photo 28.
Workshop/carpentry in
the Project main staging
area.

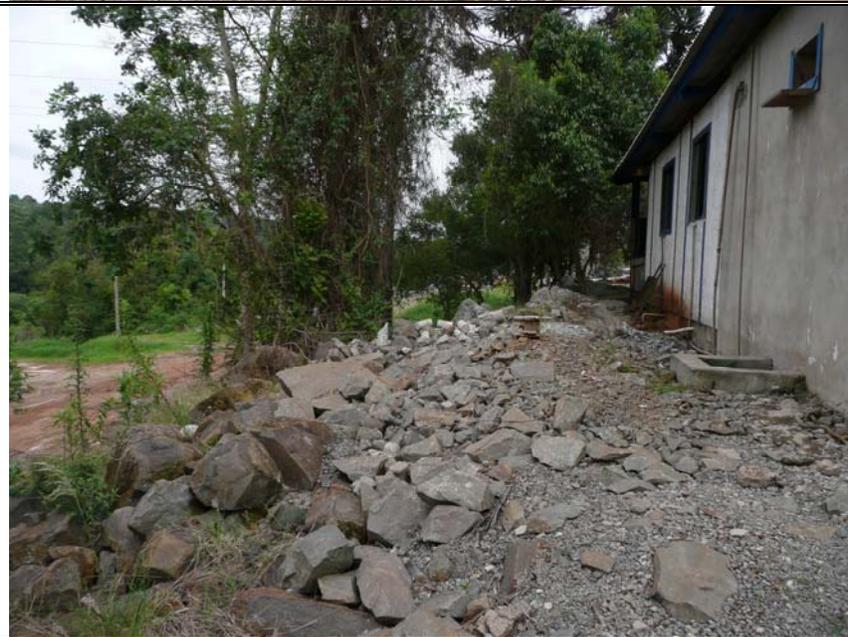
Photo 29. Location of
the septic tank system,
located behind locker
room.

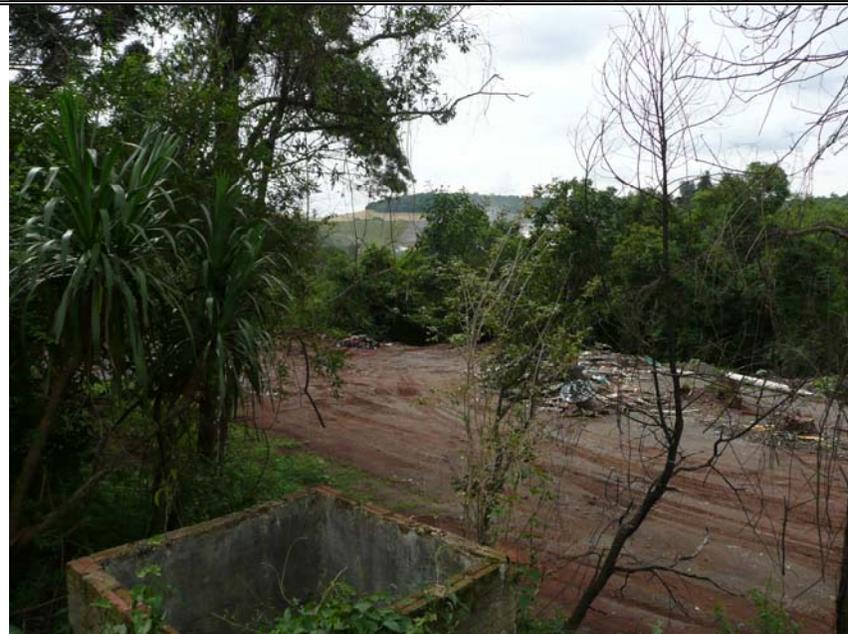
Photo 30. Housekeeping
issue. Waste and scraps
were observed on the
ground, behind locker
room area.

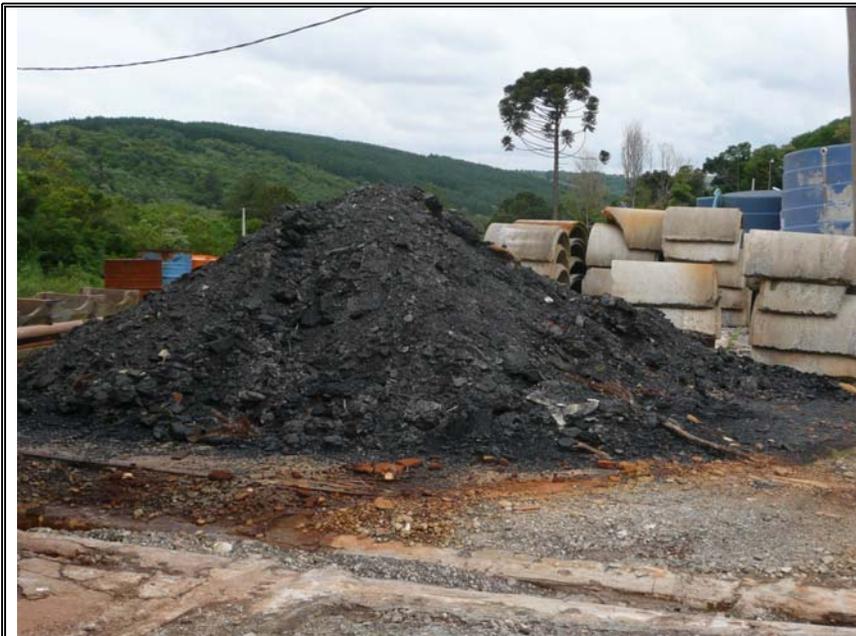
Photo 31. Pile of coal left from the construction of the PCH Ludesa, near the locker room.

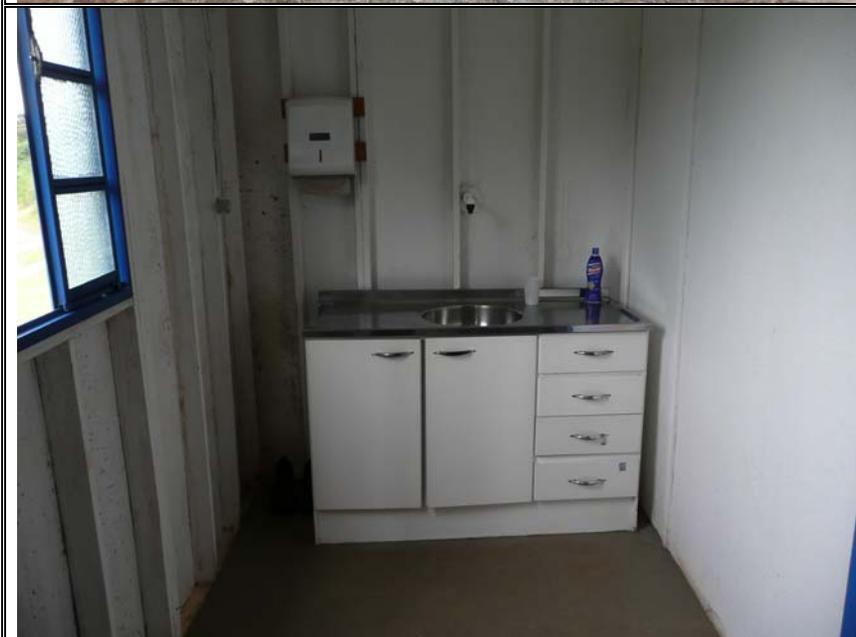
Photo 32. Onsite first-aid facility. At the time of the site visit in October, the nurse was waiting for supplies to arrive.

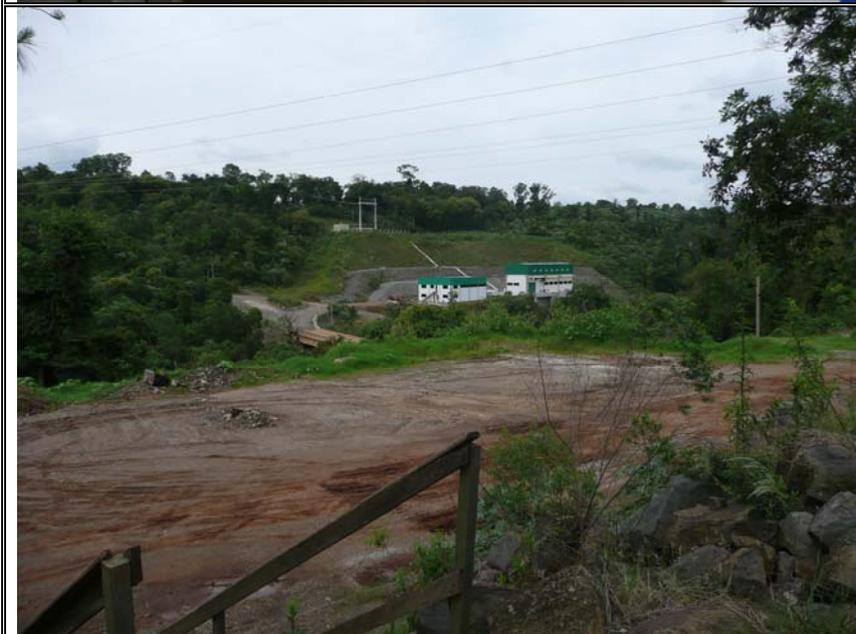
Photo 33. PCH Ludesa power house and substation. The Project will tie to this substation and then will use PCH Ludesa's transmission lines to tie to a substation connected to the national grid.
