ANNEX 15
LANDSCAPE REPORT

This report corresponds to the survey of the base line of the landscape component associated to the "Electric Transmission lines Maitenes S/S - Alfalfal S/S and Alfalfal II Power Plant - Alfalfal S/S" Project.

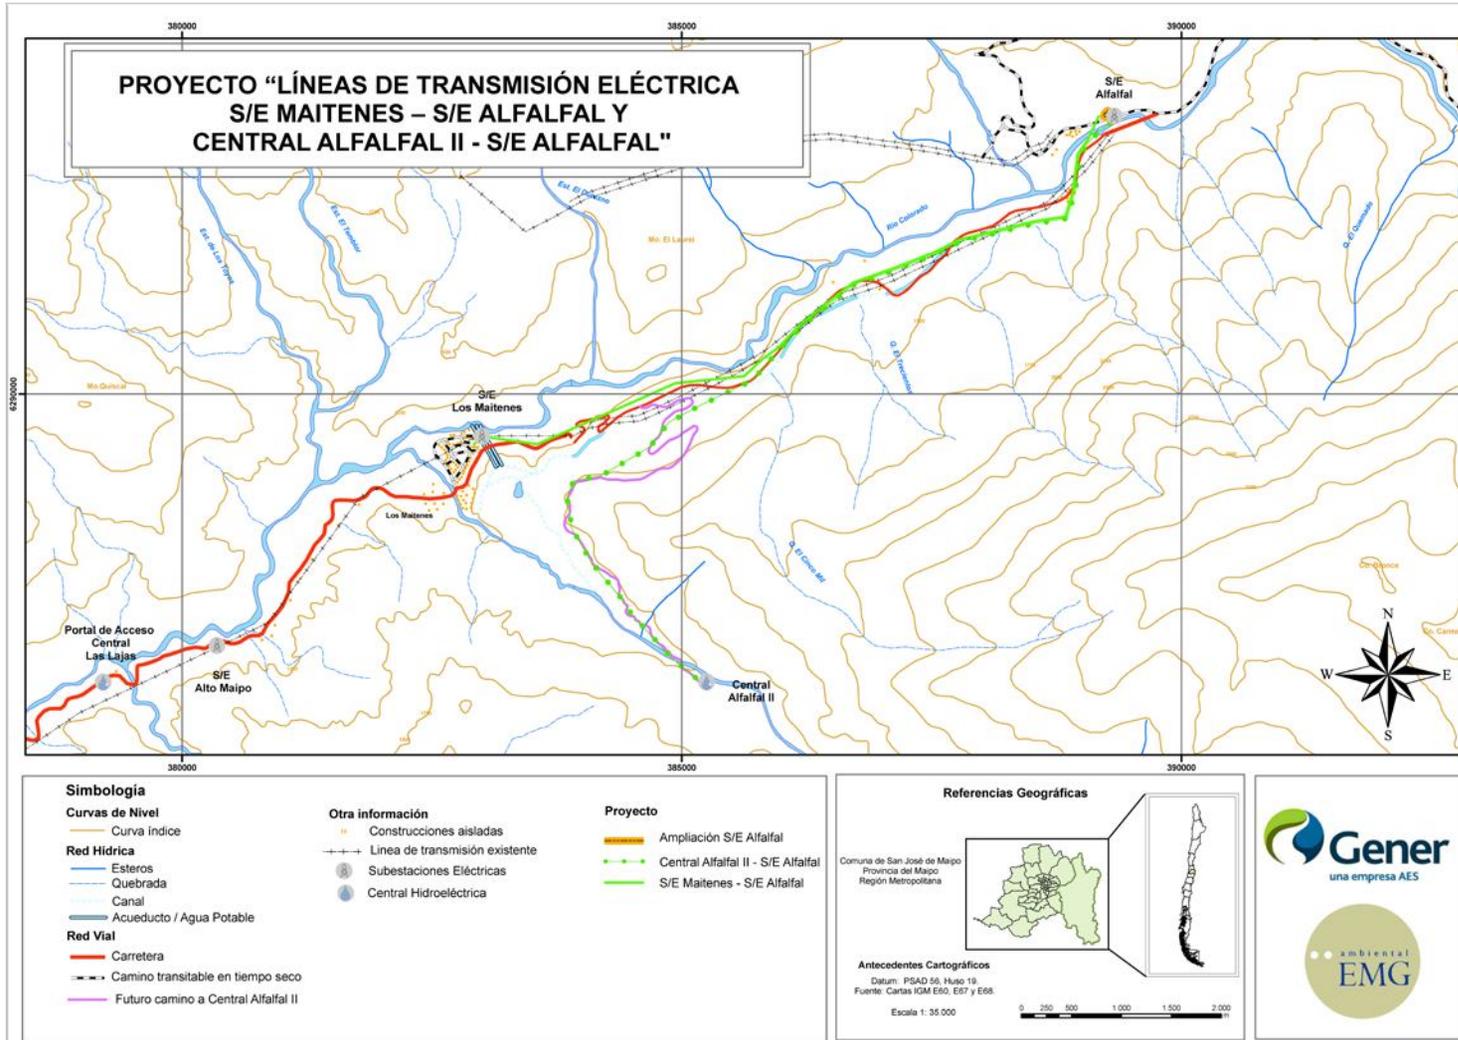
Figure 1 Location of the Project

The Project will be located in the Metropolitan region, Cordillera province, municipality of San José de Maipo, between Los Maitenes and El Alfalfal towns. The following figure shows the carry out of the Project and the related substations, located in the Colorado River basin and Aucayes stream.

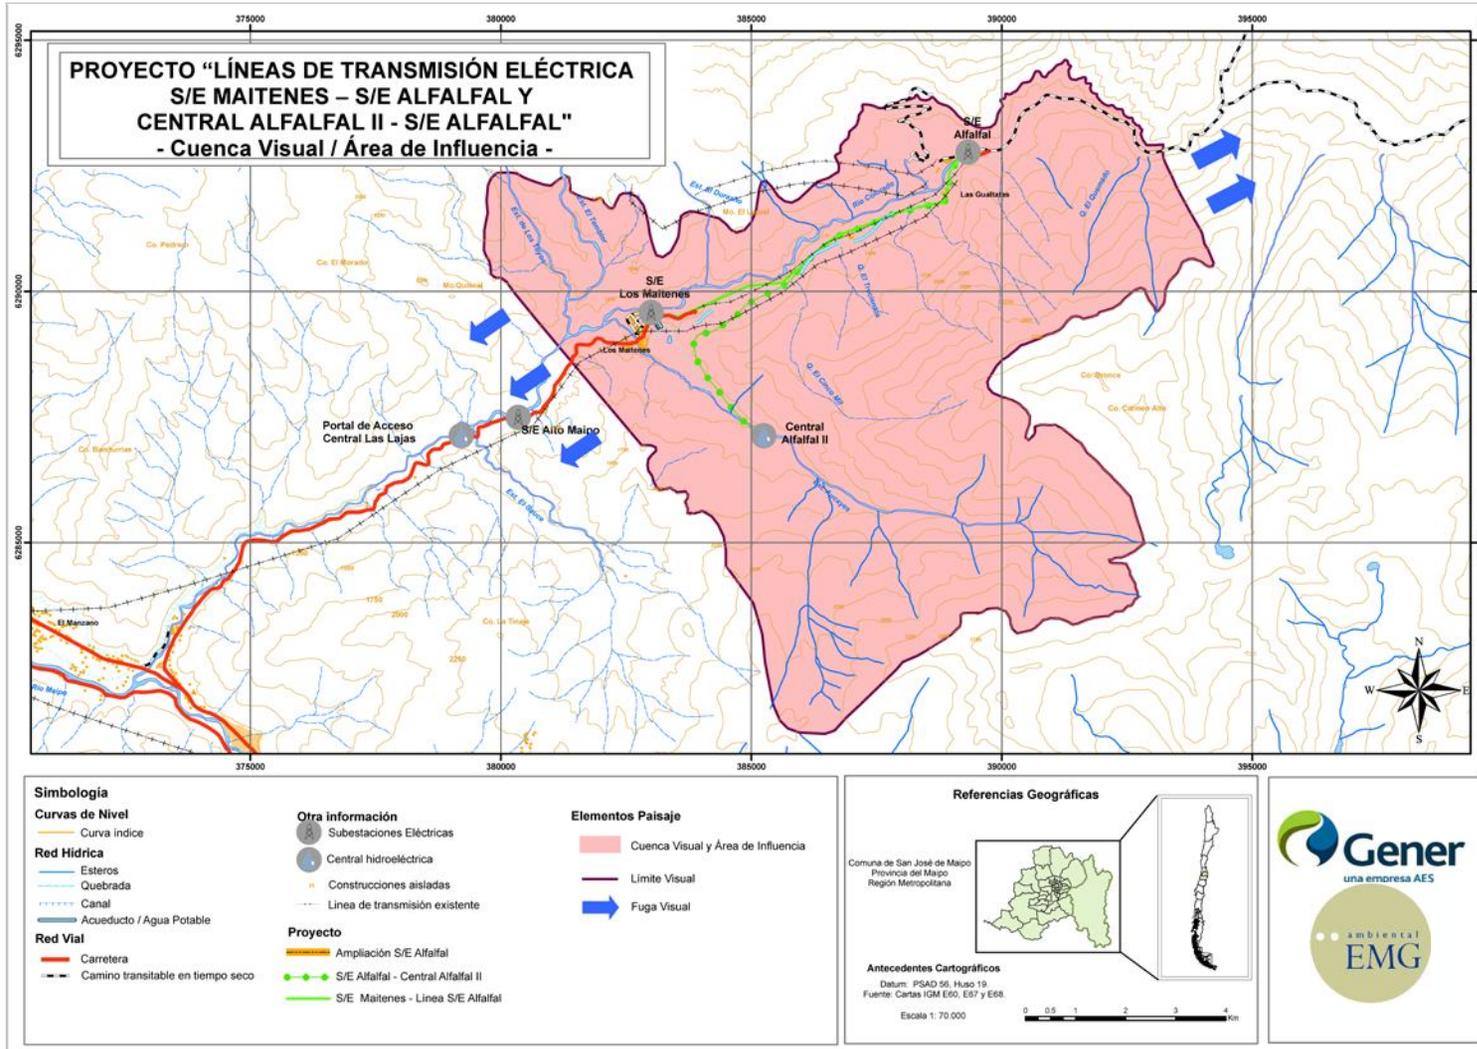
Figure 2 Visual basin and area of influence

It will be understood as influence area to the entire land portion in which the project will be carried out and that is visible by any observer. From that characteristic on, the definition of the visual basin corresponds to the influence area, because it behaves as a section of the territory and landscape with visual reach.

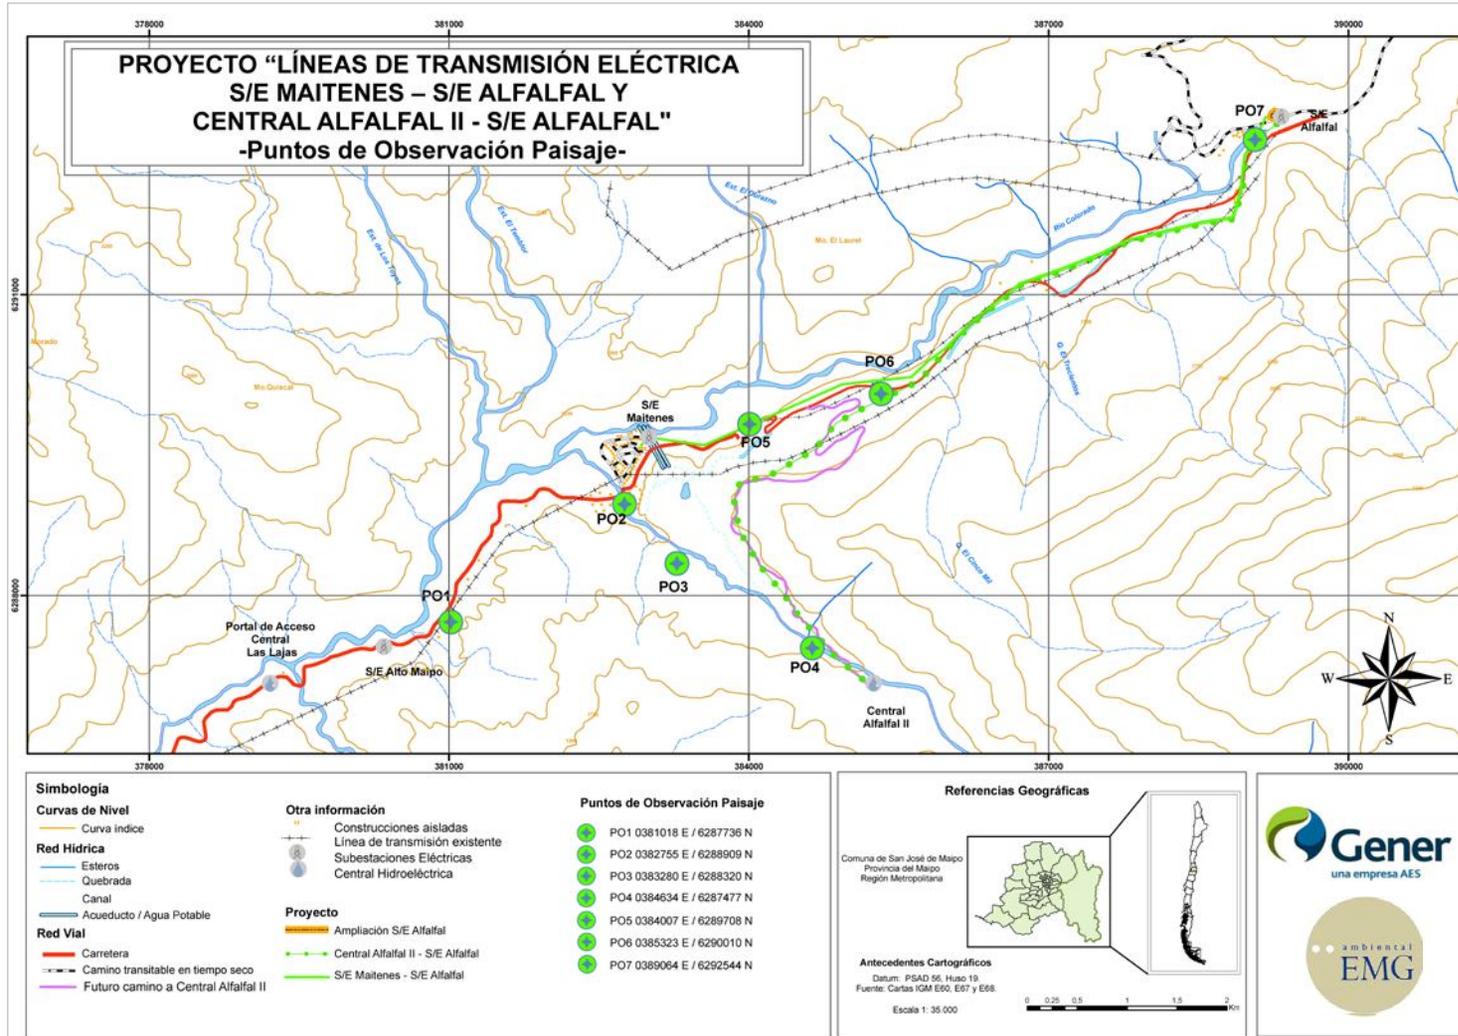
Figure 3 Landscape observation points

The visual watershed of an observation point is defined as the land surface that is visible from that point. These were registered through the photograph takes from the location of each selected observation point (see photographic record in Appendix A and location of observation points in Figure 3). The basins were projected with a panoramic broad over the areas that the Project would have visual influence.

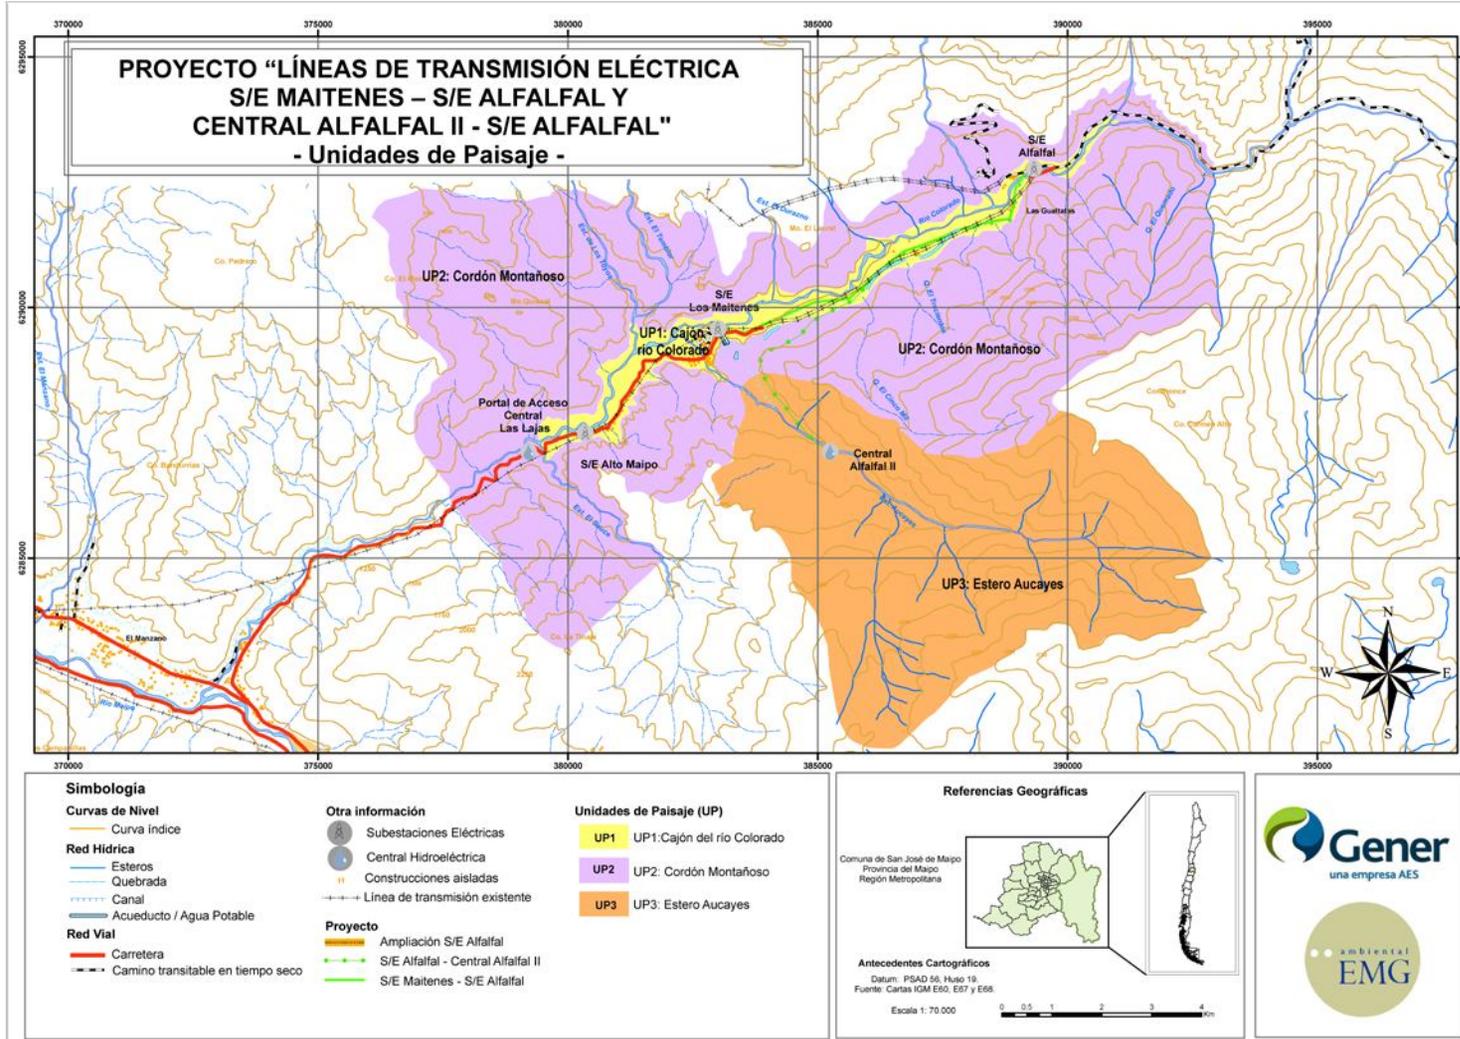
Figure 4 Landscape Units in the influence area

In the following figure, aerial views of the study, the identified landscape units for the Project.

For the impacts identification and assessment, the carry out area of the Project was visualized from the observation points determined in field, both by its visual access as for the constitution of areas with potential interest where the projected facilities might be observed (see Figure 4).

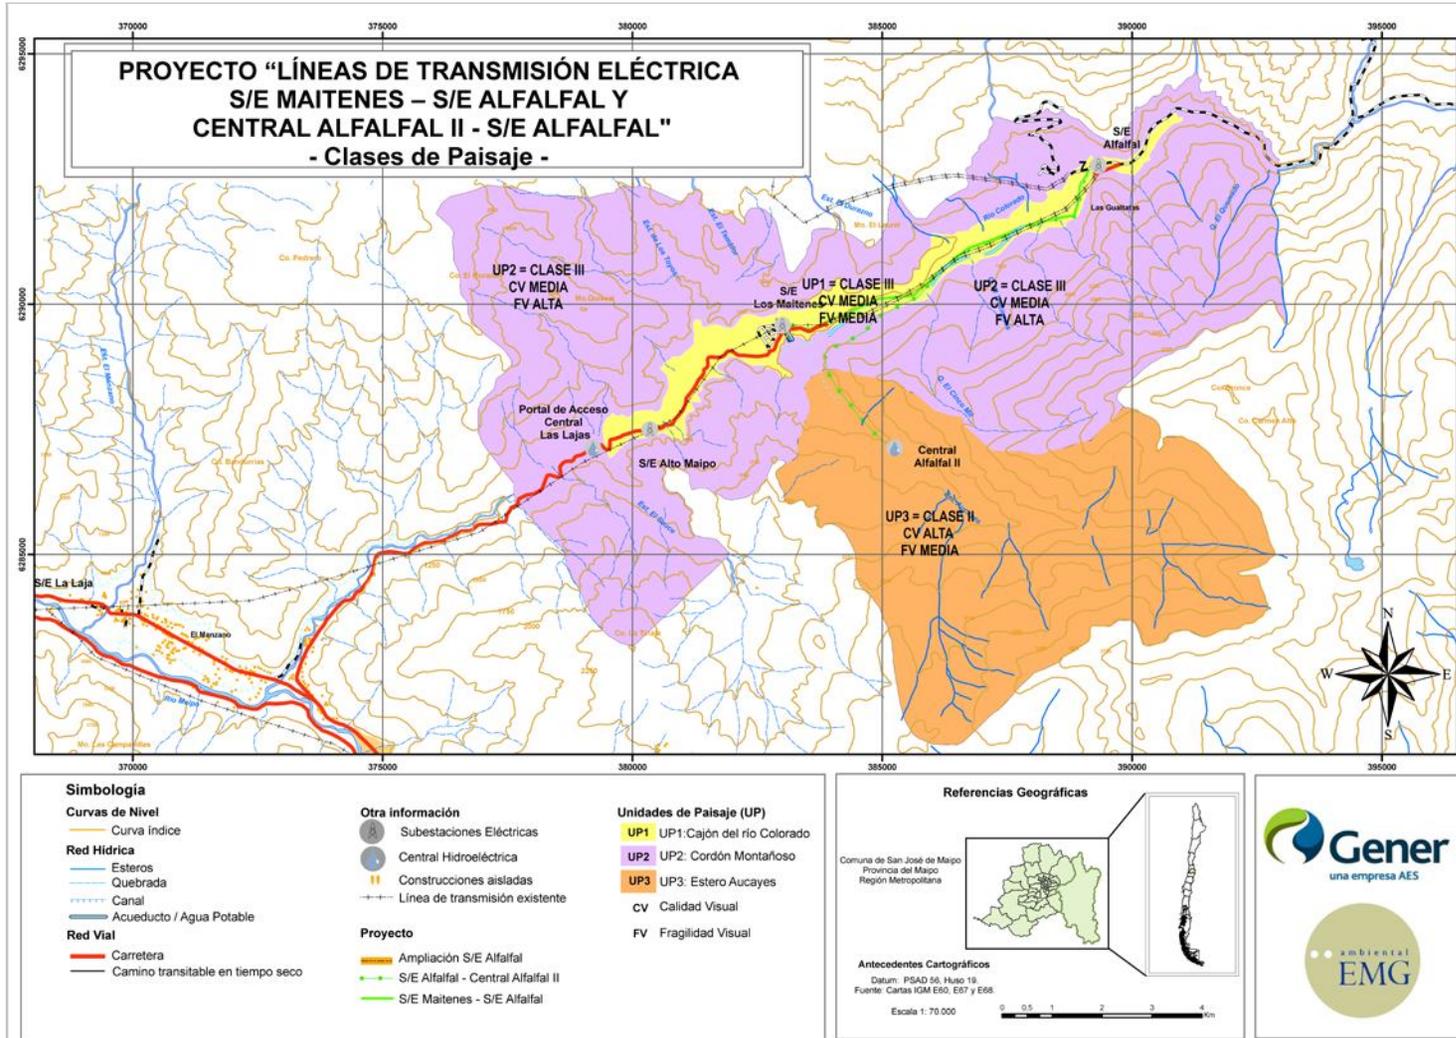
Figure 5 Landscape Units classes in the area of influence

The following figure shows the landscape units in the area of influence, and the results with regards the Landscape Class; condition which contributes the resistance degree in front of possible impacts.
