Ardiseis

FINAL REPORT

SIWA SALLUM 3D
3D HPVA Vibroseis

APACHE

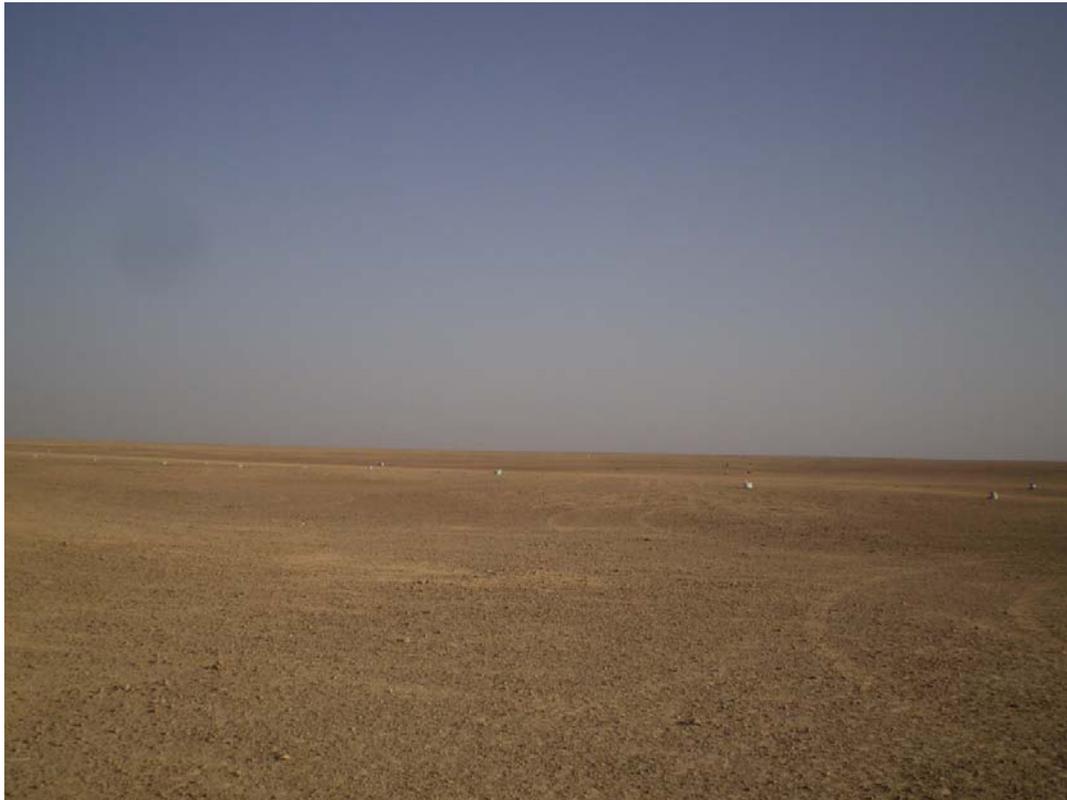
Figure 6 – View of the 3D survey.

The topography in this region is flat desert with an elevation difference upto 40 meters of the whole prospect .
